TEST ANALYSIS REPORT FOR:

## **BARRIERTEK FULL-SCALE BURN DEMONSTRATIONS NISKU, ALBERTA**

LRI File: 26982

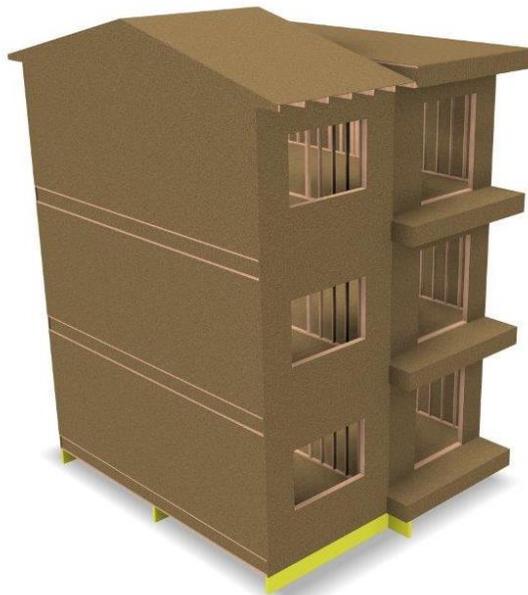
**Drawing 1** – Rendering of the experimental building.

The test buildings used in the experiment consisted of two identical structures: one treated with an intumescent coating, while the other remained untreated. The floor plans of each storey were intended to represent commercially typical single-bedroom layouts which included a bedroom, closet, bathroom, kitchen/dining area and a living room. Interior stud walls were installed, but were not boarded with gypsum, and therefore, the storeys were essentially representative of a building under construction that was nearing completion of the framing stage [**Drawing 1 & Photo 1**].

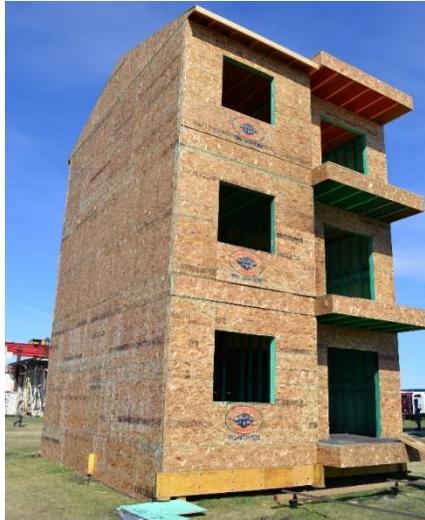
**Photo 1** – Photograph of the treated experimental building.

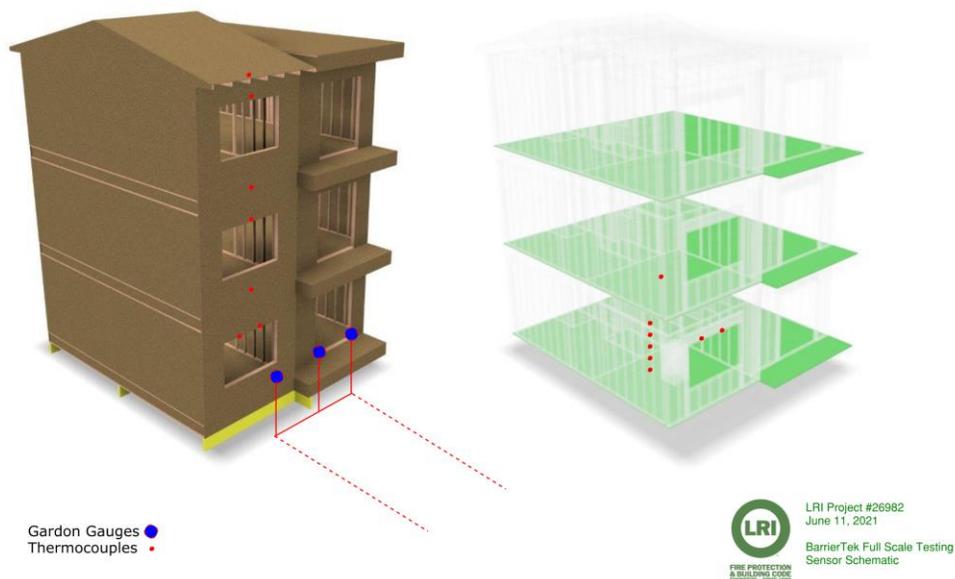
**Drawing 2** – Sensor position schematic [Appendix B], LVL sensors not shown.

Sensors were positioned within and in front of the structures. Type K thermocouples were used for monitoring temperature, while Hukseflux Gardon Gauges were positioned outside the structures to monitor heat flux emanating from the buildings. 16 thermocouples were used in each structure, with three Gardon Gauges positioned across the front of the structure mounted to a repositionable sled [Drawing 2 & Appendix B].

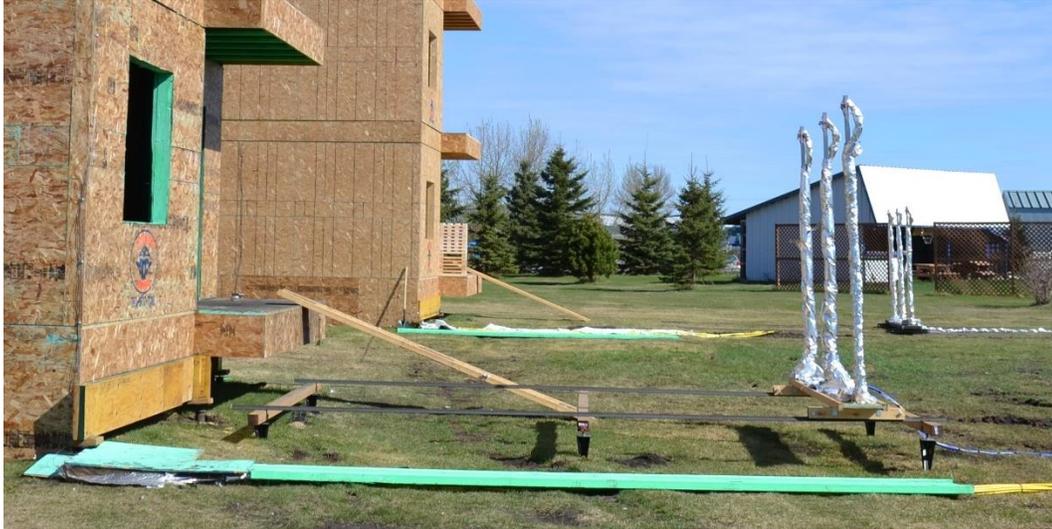
Three sensors on vertical supports which were mounted onto repositionable sleds [**Photo 2**]. The central sensor was approximately centred on the building. The two side sensors were each positioned 1.7 m away from the central sensor. The resulting coverage had a sensor located at approximately 25%, 50% and 75% of the width of the building.

**Photo 2** – Gardon Gauges mounted to the sleds.

The use of a repositionable sled permitted the gauges to be moved during the testing as the measured heat flux reached the maximum capacity of each gauge in order to prevent sensor damage. The initial sensor placement placed the row of gauges 1.2 m from the front of the building face. Markings for second positions were located 2.4 m from the building face and 3.6 m from the building face. The time when the sled was moved was recorded in observation notes.

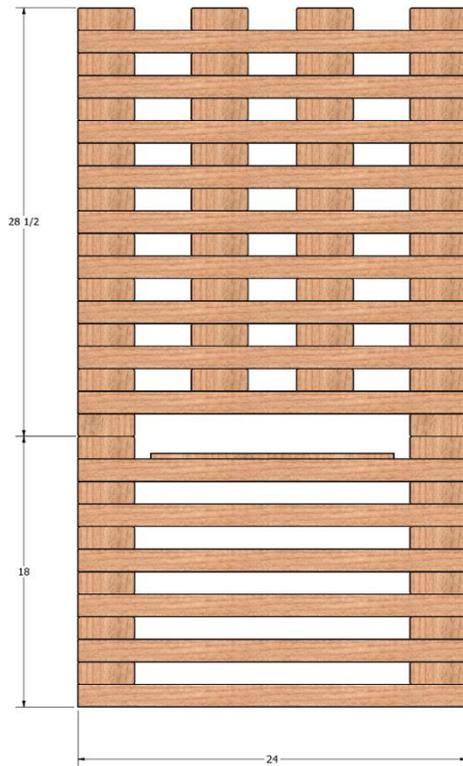
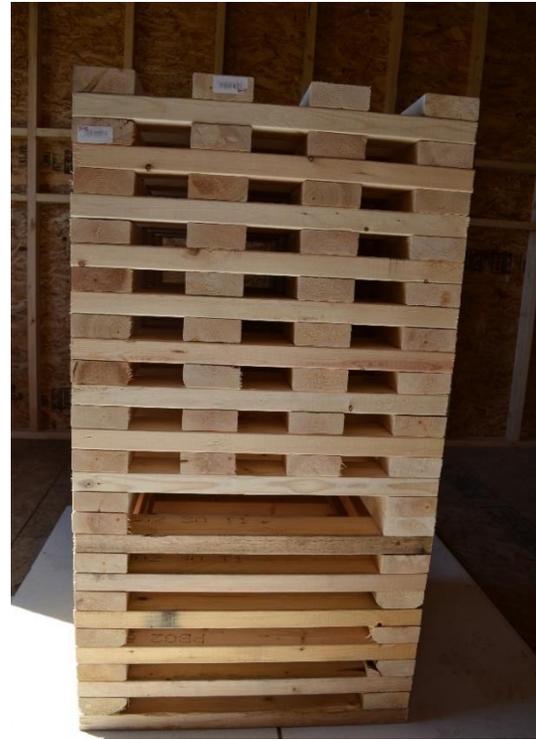
**Drawing 3** – Wood crib used for the initial fuel package.

The fuel packages for each structure were constructed using nominal 2 x 4 spruce pine fir (SPF) dimensional lumber arranged in a regular array (wood crib). Each crib consisted of 18 layers, with four sticks per layer. Each stick was cut into 610 mm (24") lengths, and was spaced approximately 89 mm (one stick width) apart. The overall dimensions of the wood crib was 610 mm wide, 610 mm long, and 686 mm tall [**Drawing 3**].

The mass of wood in the crib was 68 kg. The average moisture content of the wood on the day of the testing was 6.5% in the treated building and 7.1% in the untreated building.

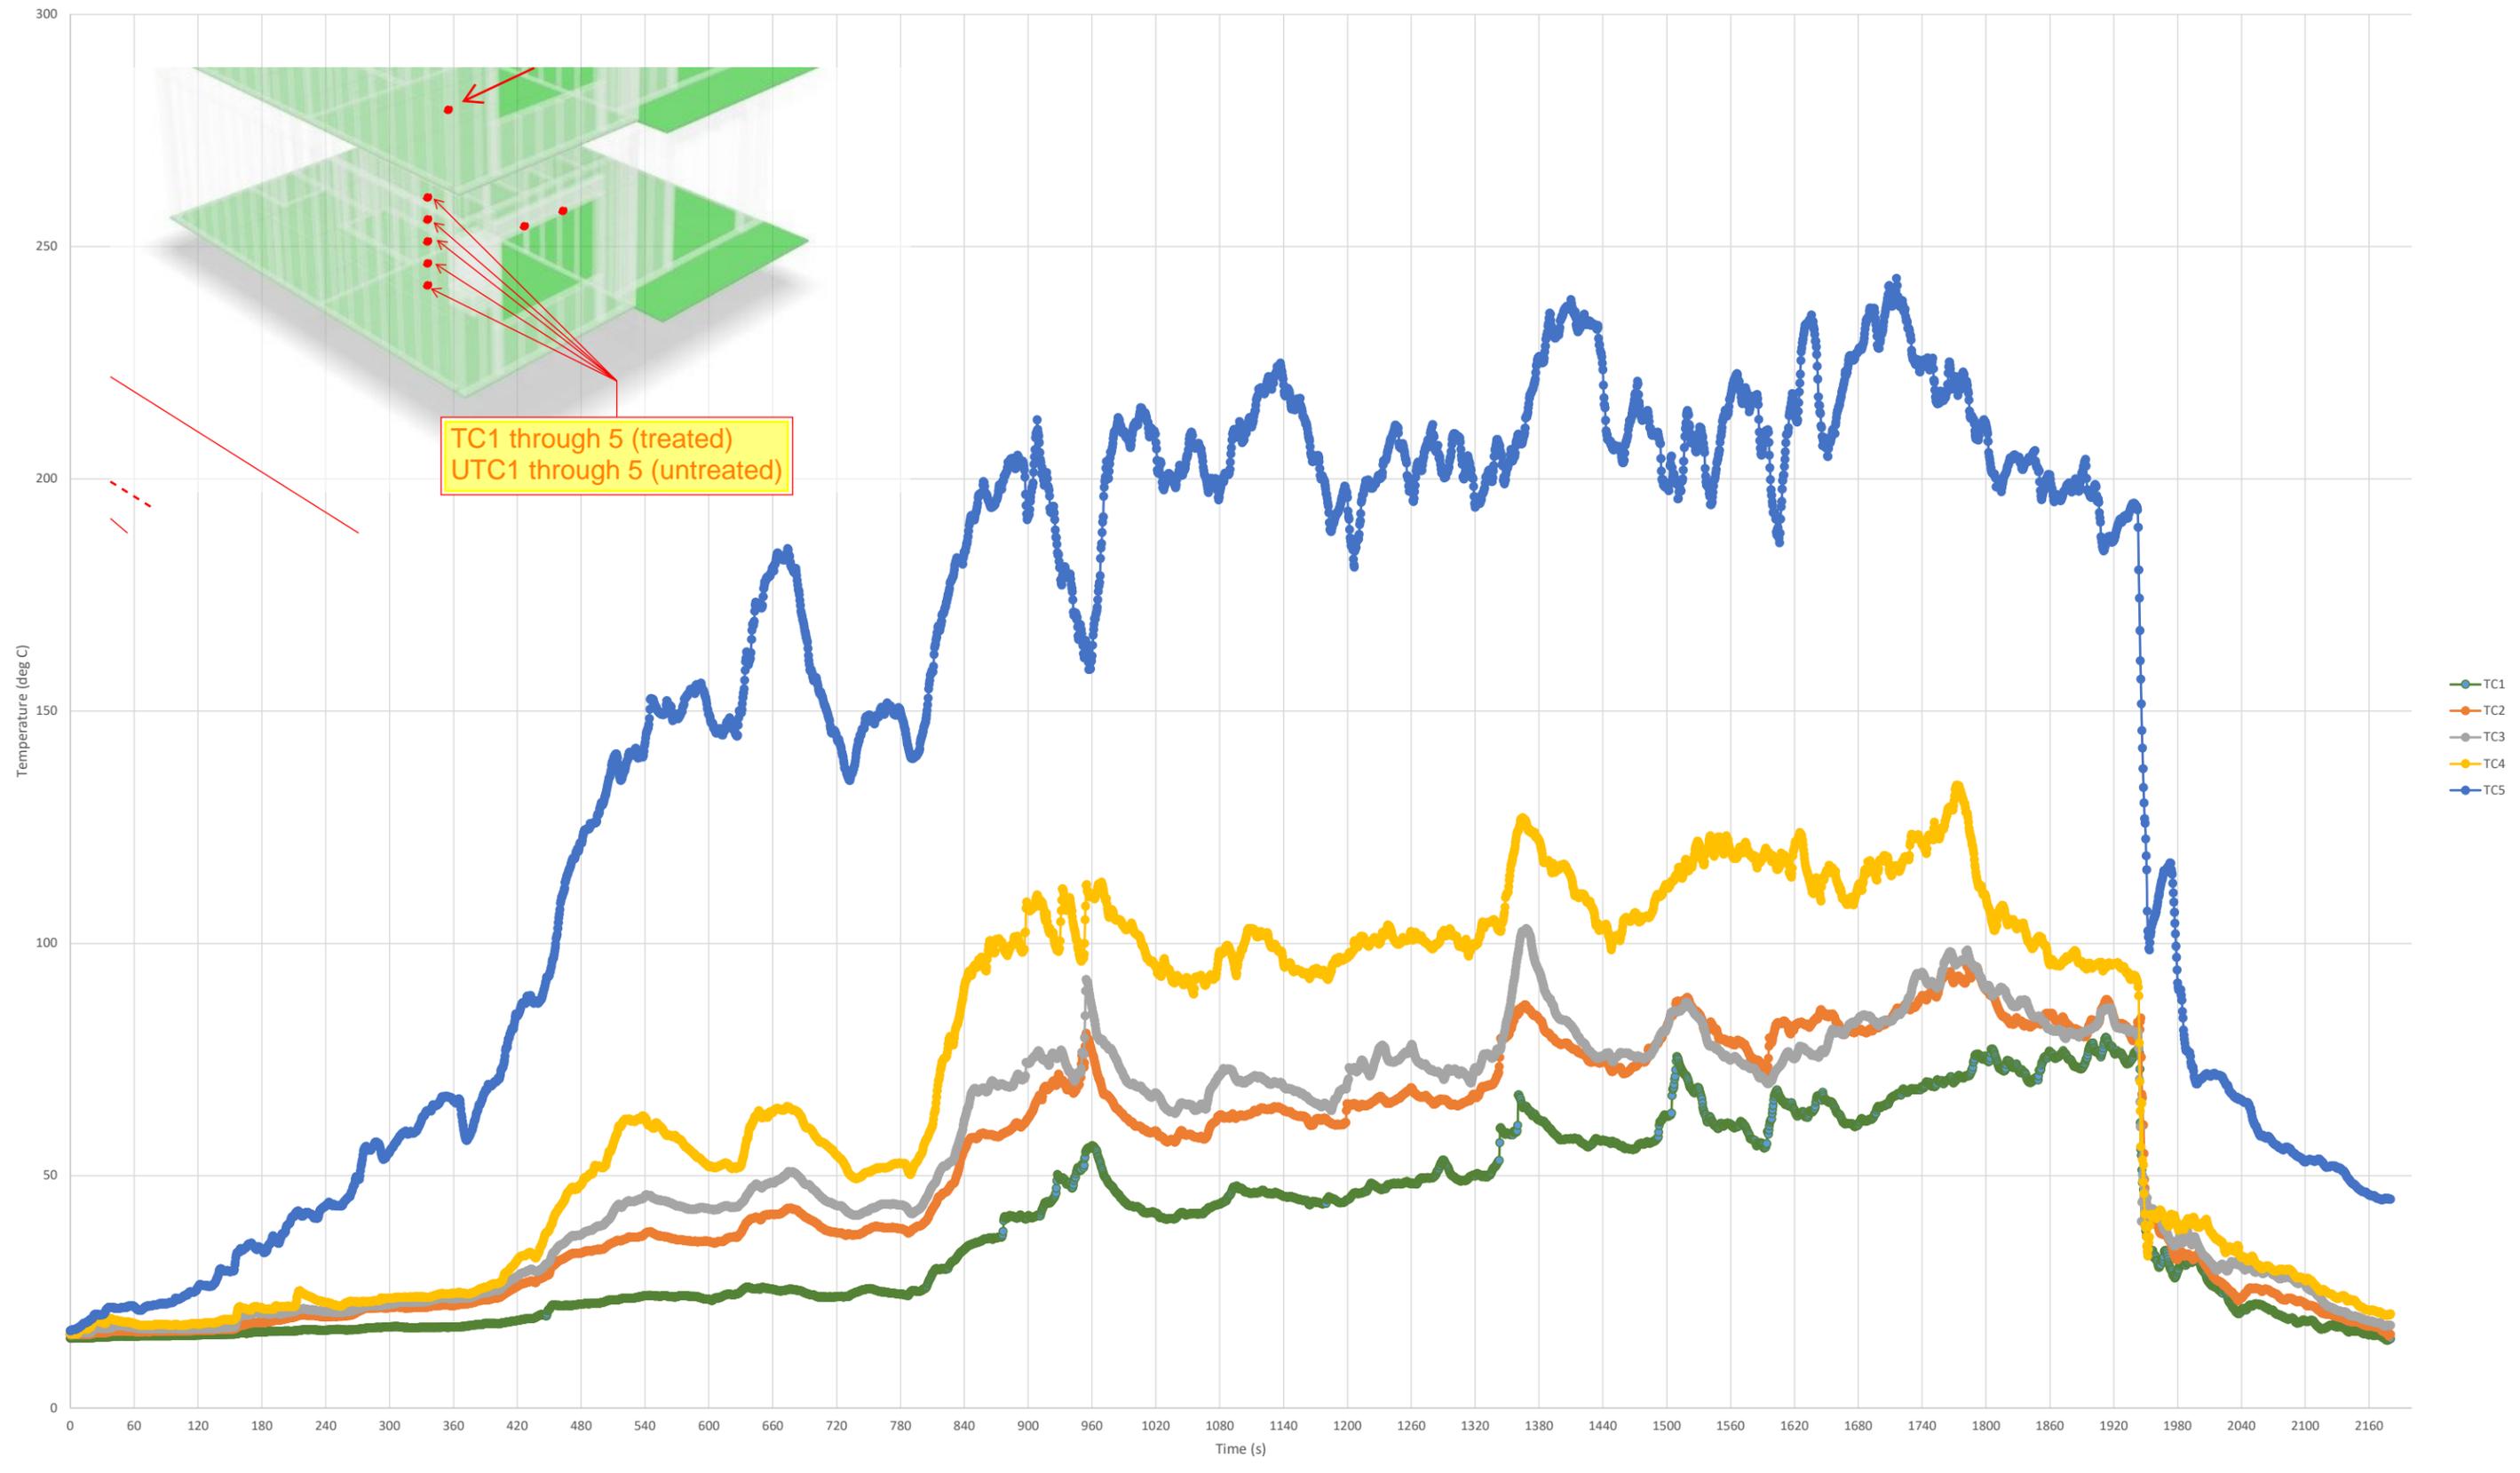
Figure 1

Treated Building Thermocouple Tree

substantial changes occur, such as when the building begins to contribute to the fire. [**See Figures 1 & 2 in Appendix A**]

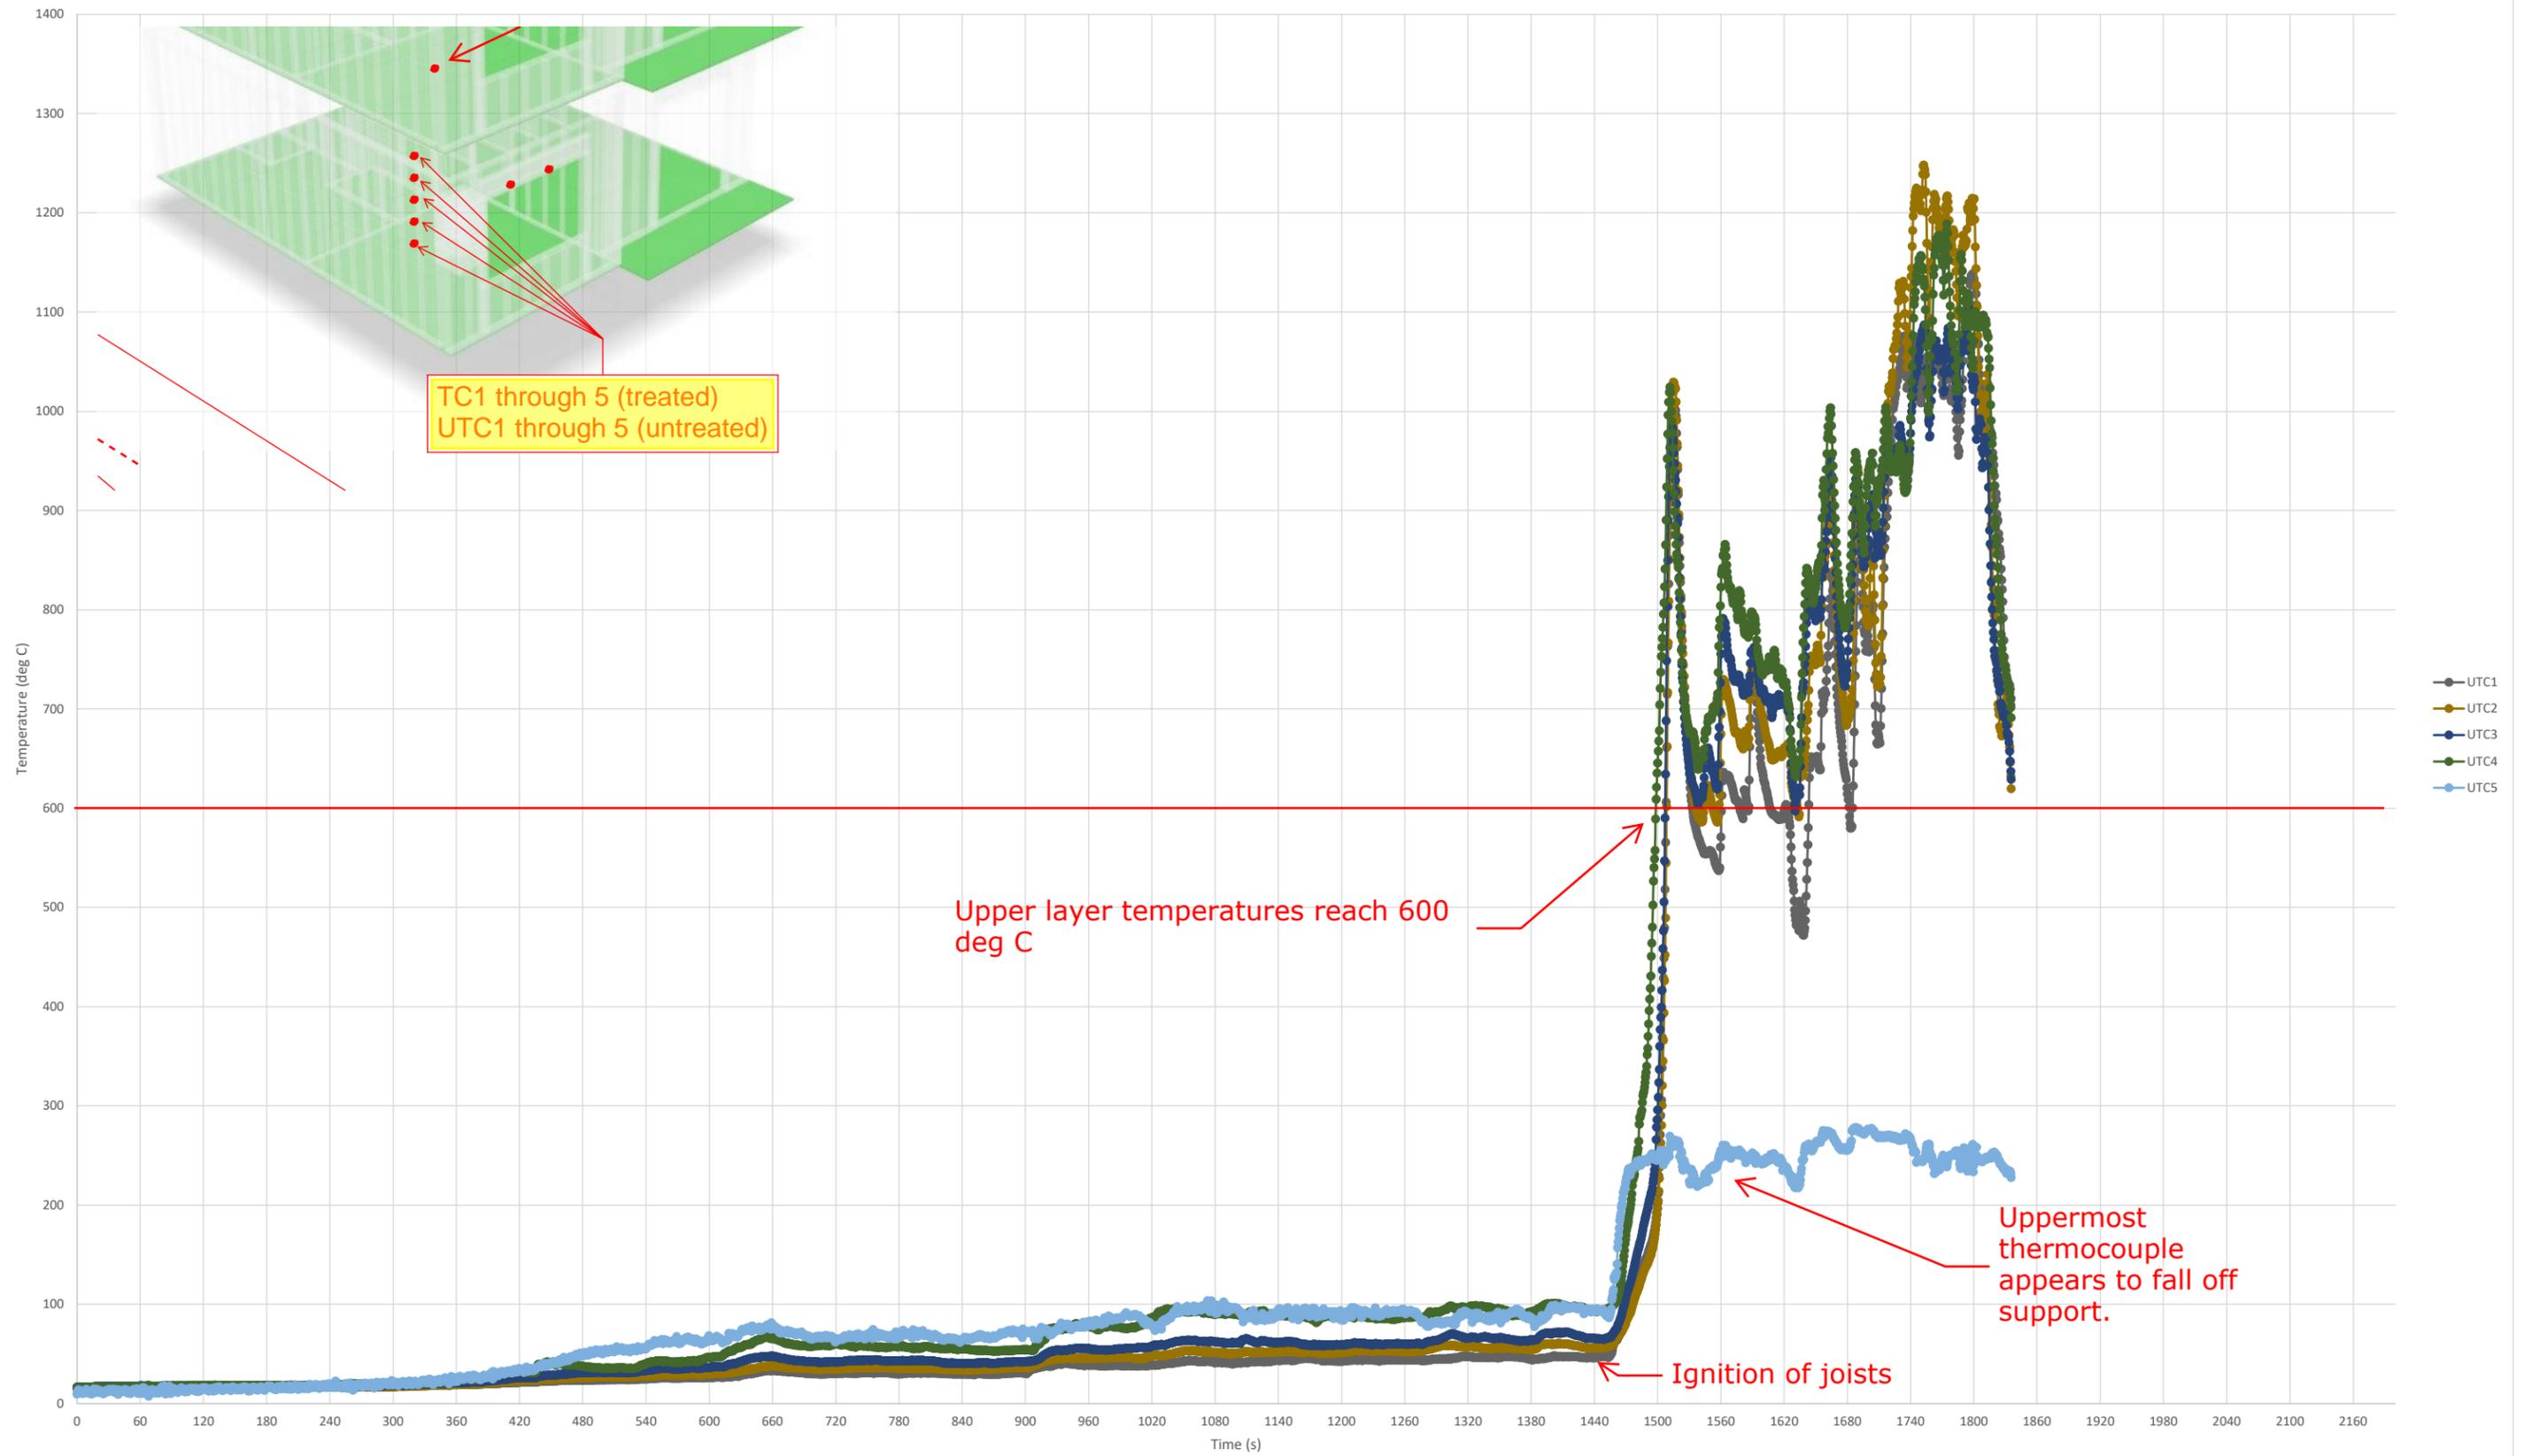
Figure 2

Untreated Building Thermocouple Tree

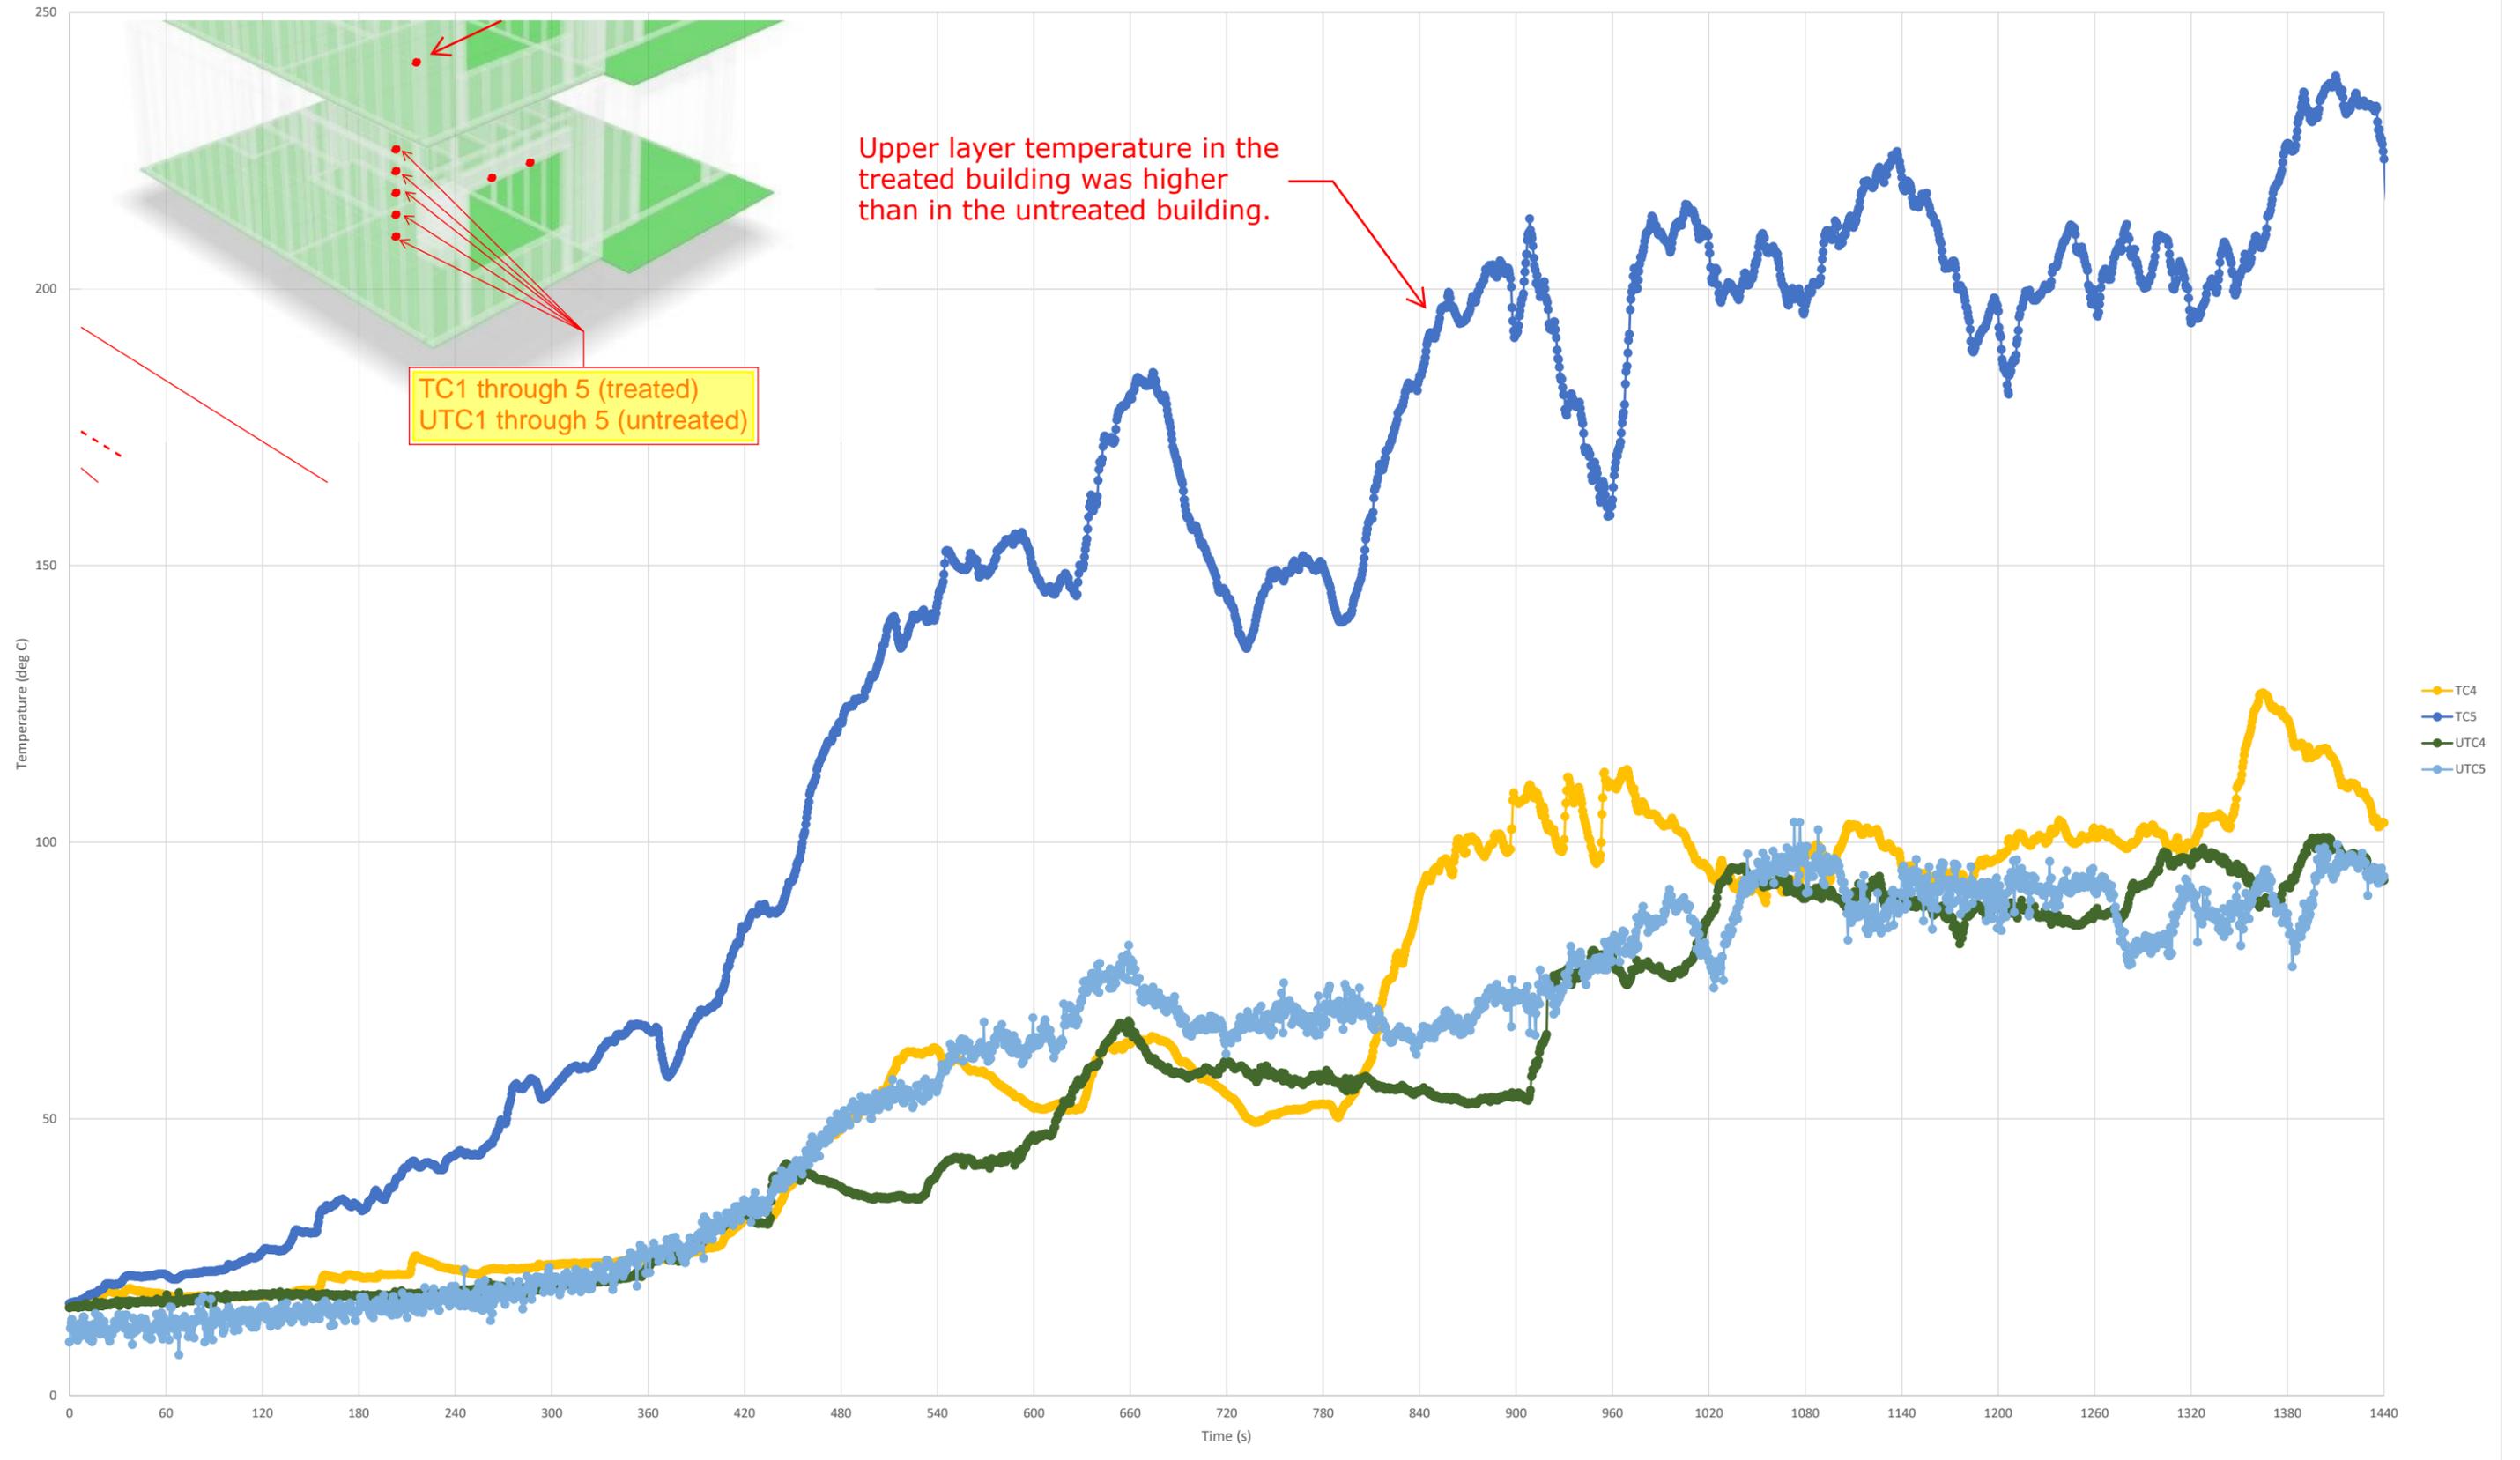
Figure 3

Comparison of upper layer temperatures prior to structure catching fire

- Upper layer temperatures at 2.20 m above the floor rose from ambient to approximately 100°C at approximately the same time 840-1020 s after the ignition of the fuel package. This is consistent with the expected results due to the comparable geometry of the structures combined with the standardized fuel package [**Figure 3**].

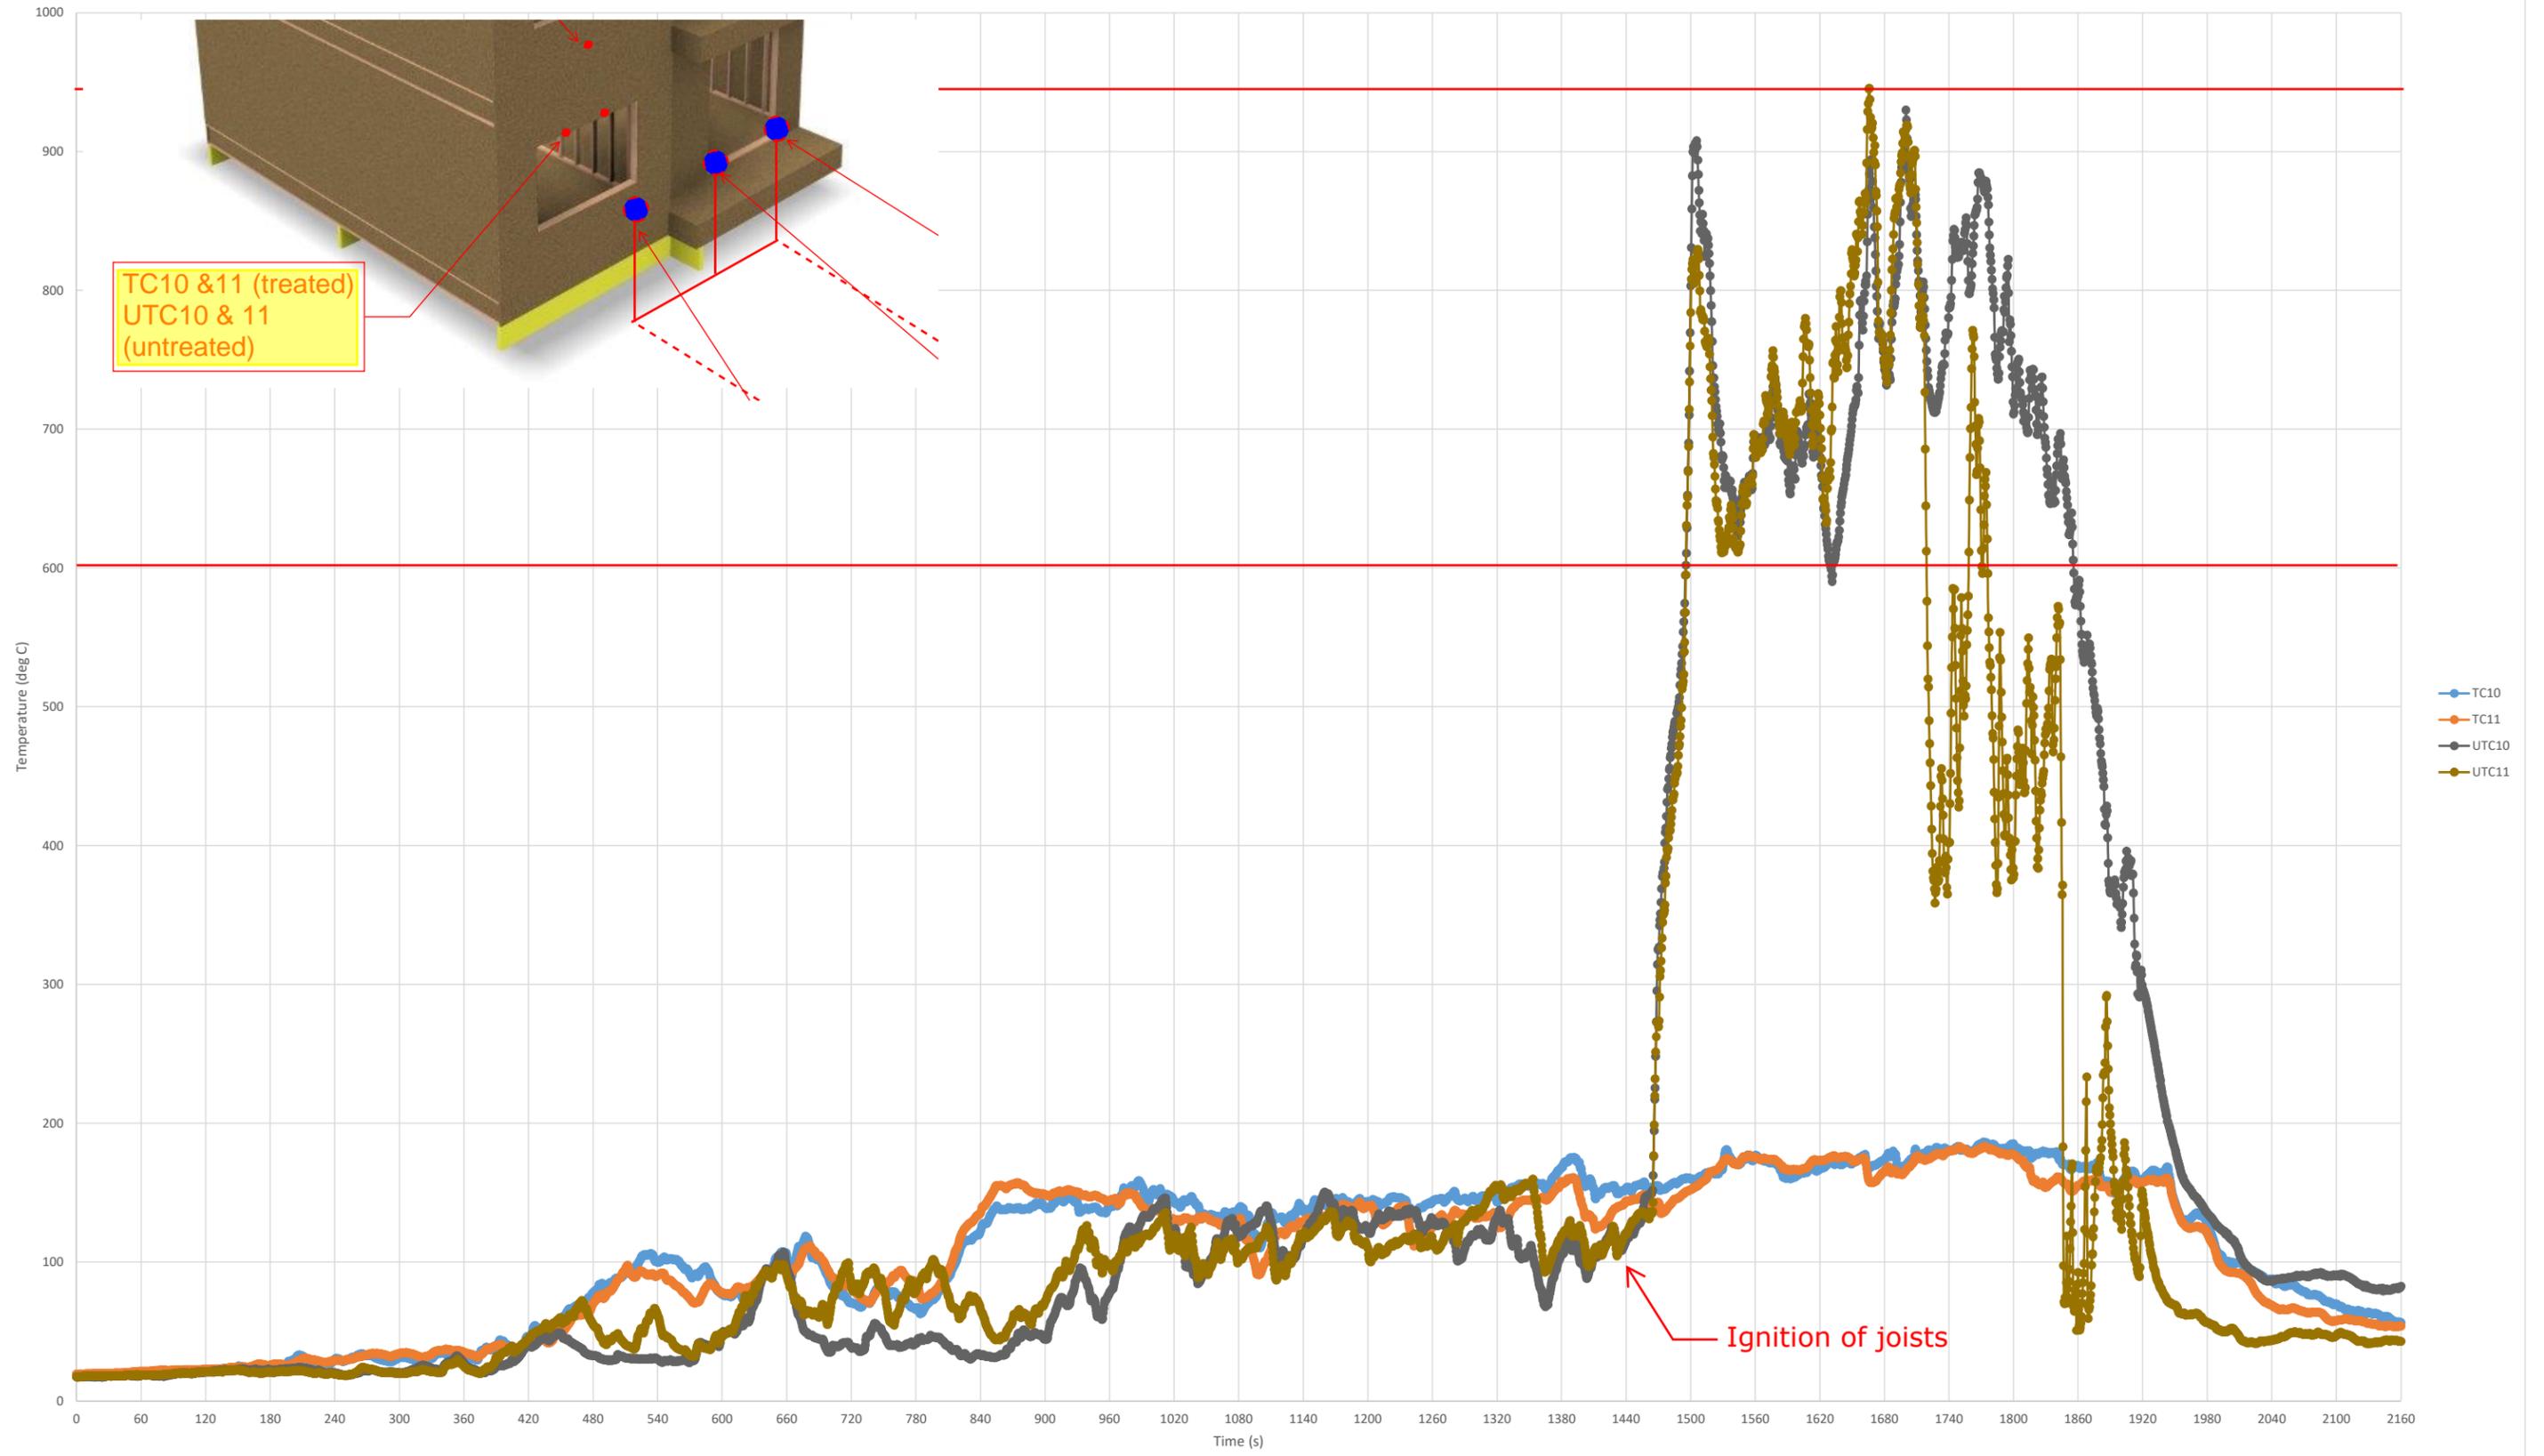
Figure 4

Window header temperature comparison

quantitatively establish the impact of the coating on fire growth at faces which would be exposing building faces. [**See Figures 4 through 7 in Appendix A**]

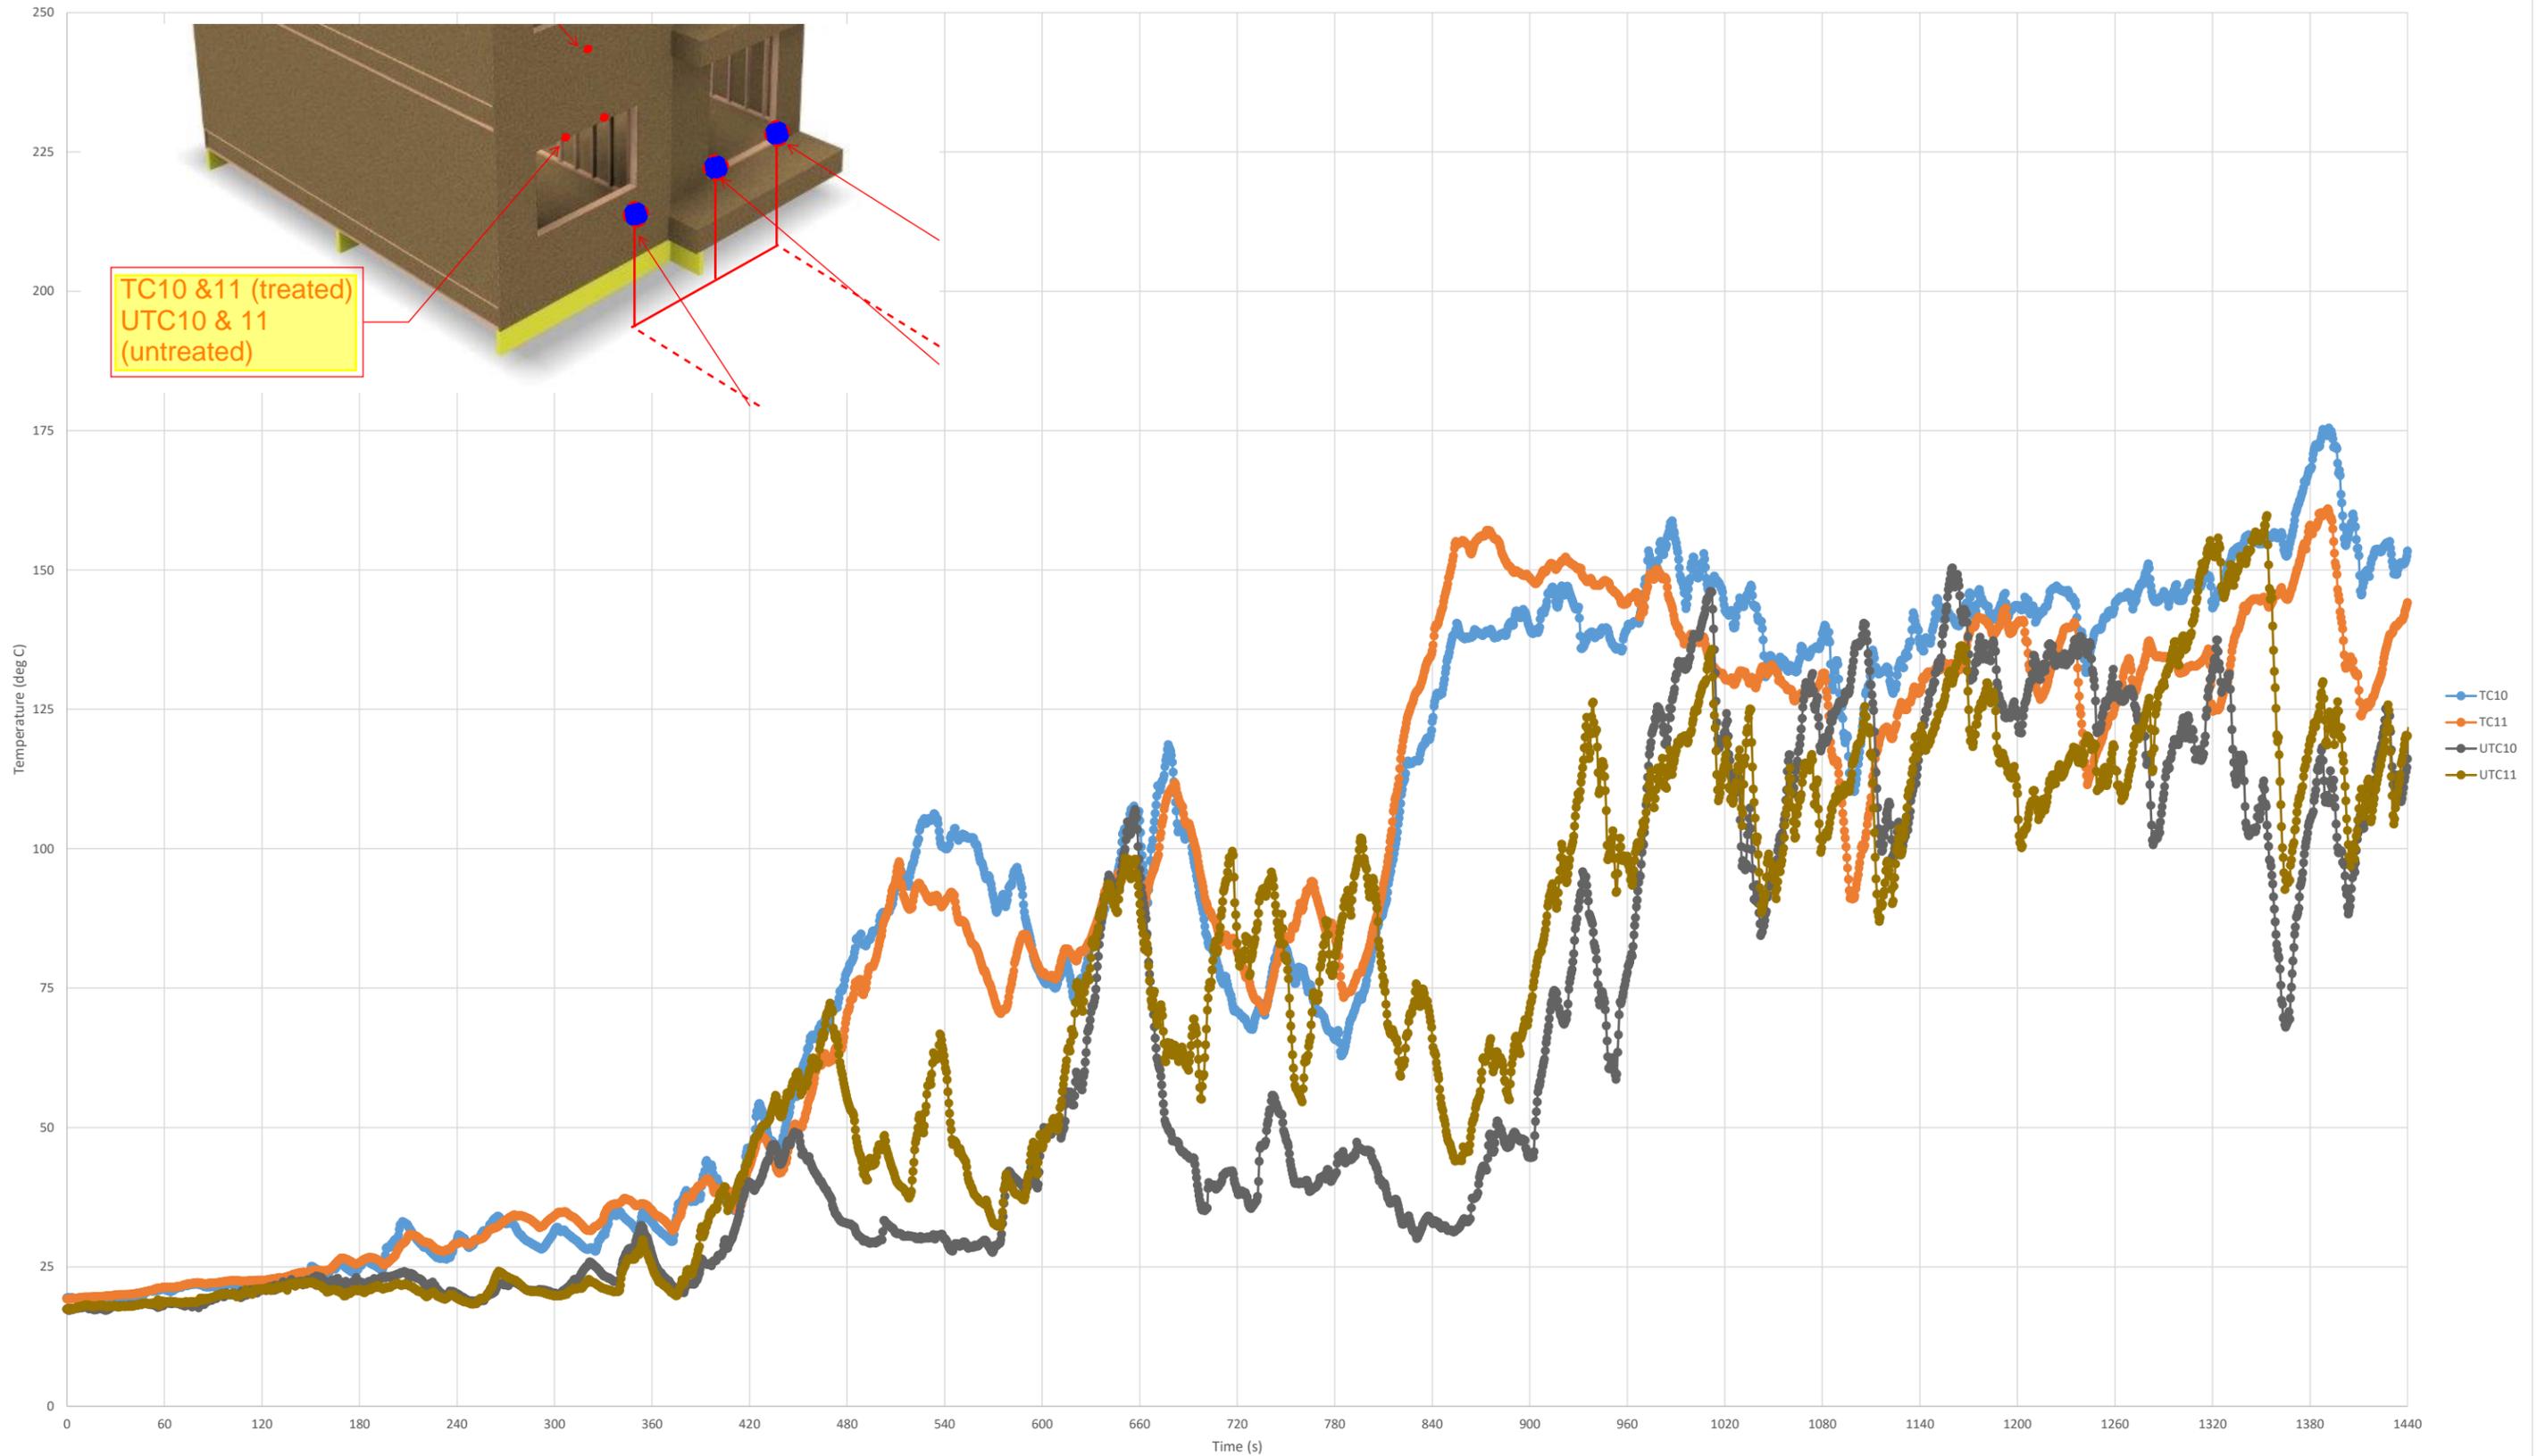
Figure 5

Window header temperature comparison prior to ignition of structure

- Gas temperatures at the window header in the bedroom in front of the fuel package was consistent around 115-140°C between both buildings until the ignition of the untreated building occurred at 1440 s. This supports that a comparable level of heat loss through convection and ventilation as the temperatures and wind speeds were comparable during both fires [**Figure 5**].
