TEST ANALYSIS REPORT FOR:

## **BARRIERTEK FULL-SCALE BURN DEMONSTRATIONS NISKU, ALBERTA**

LRI File: 26982

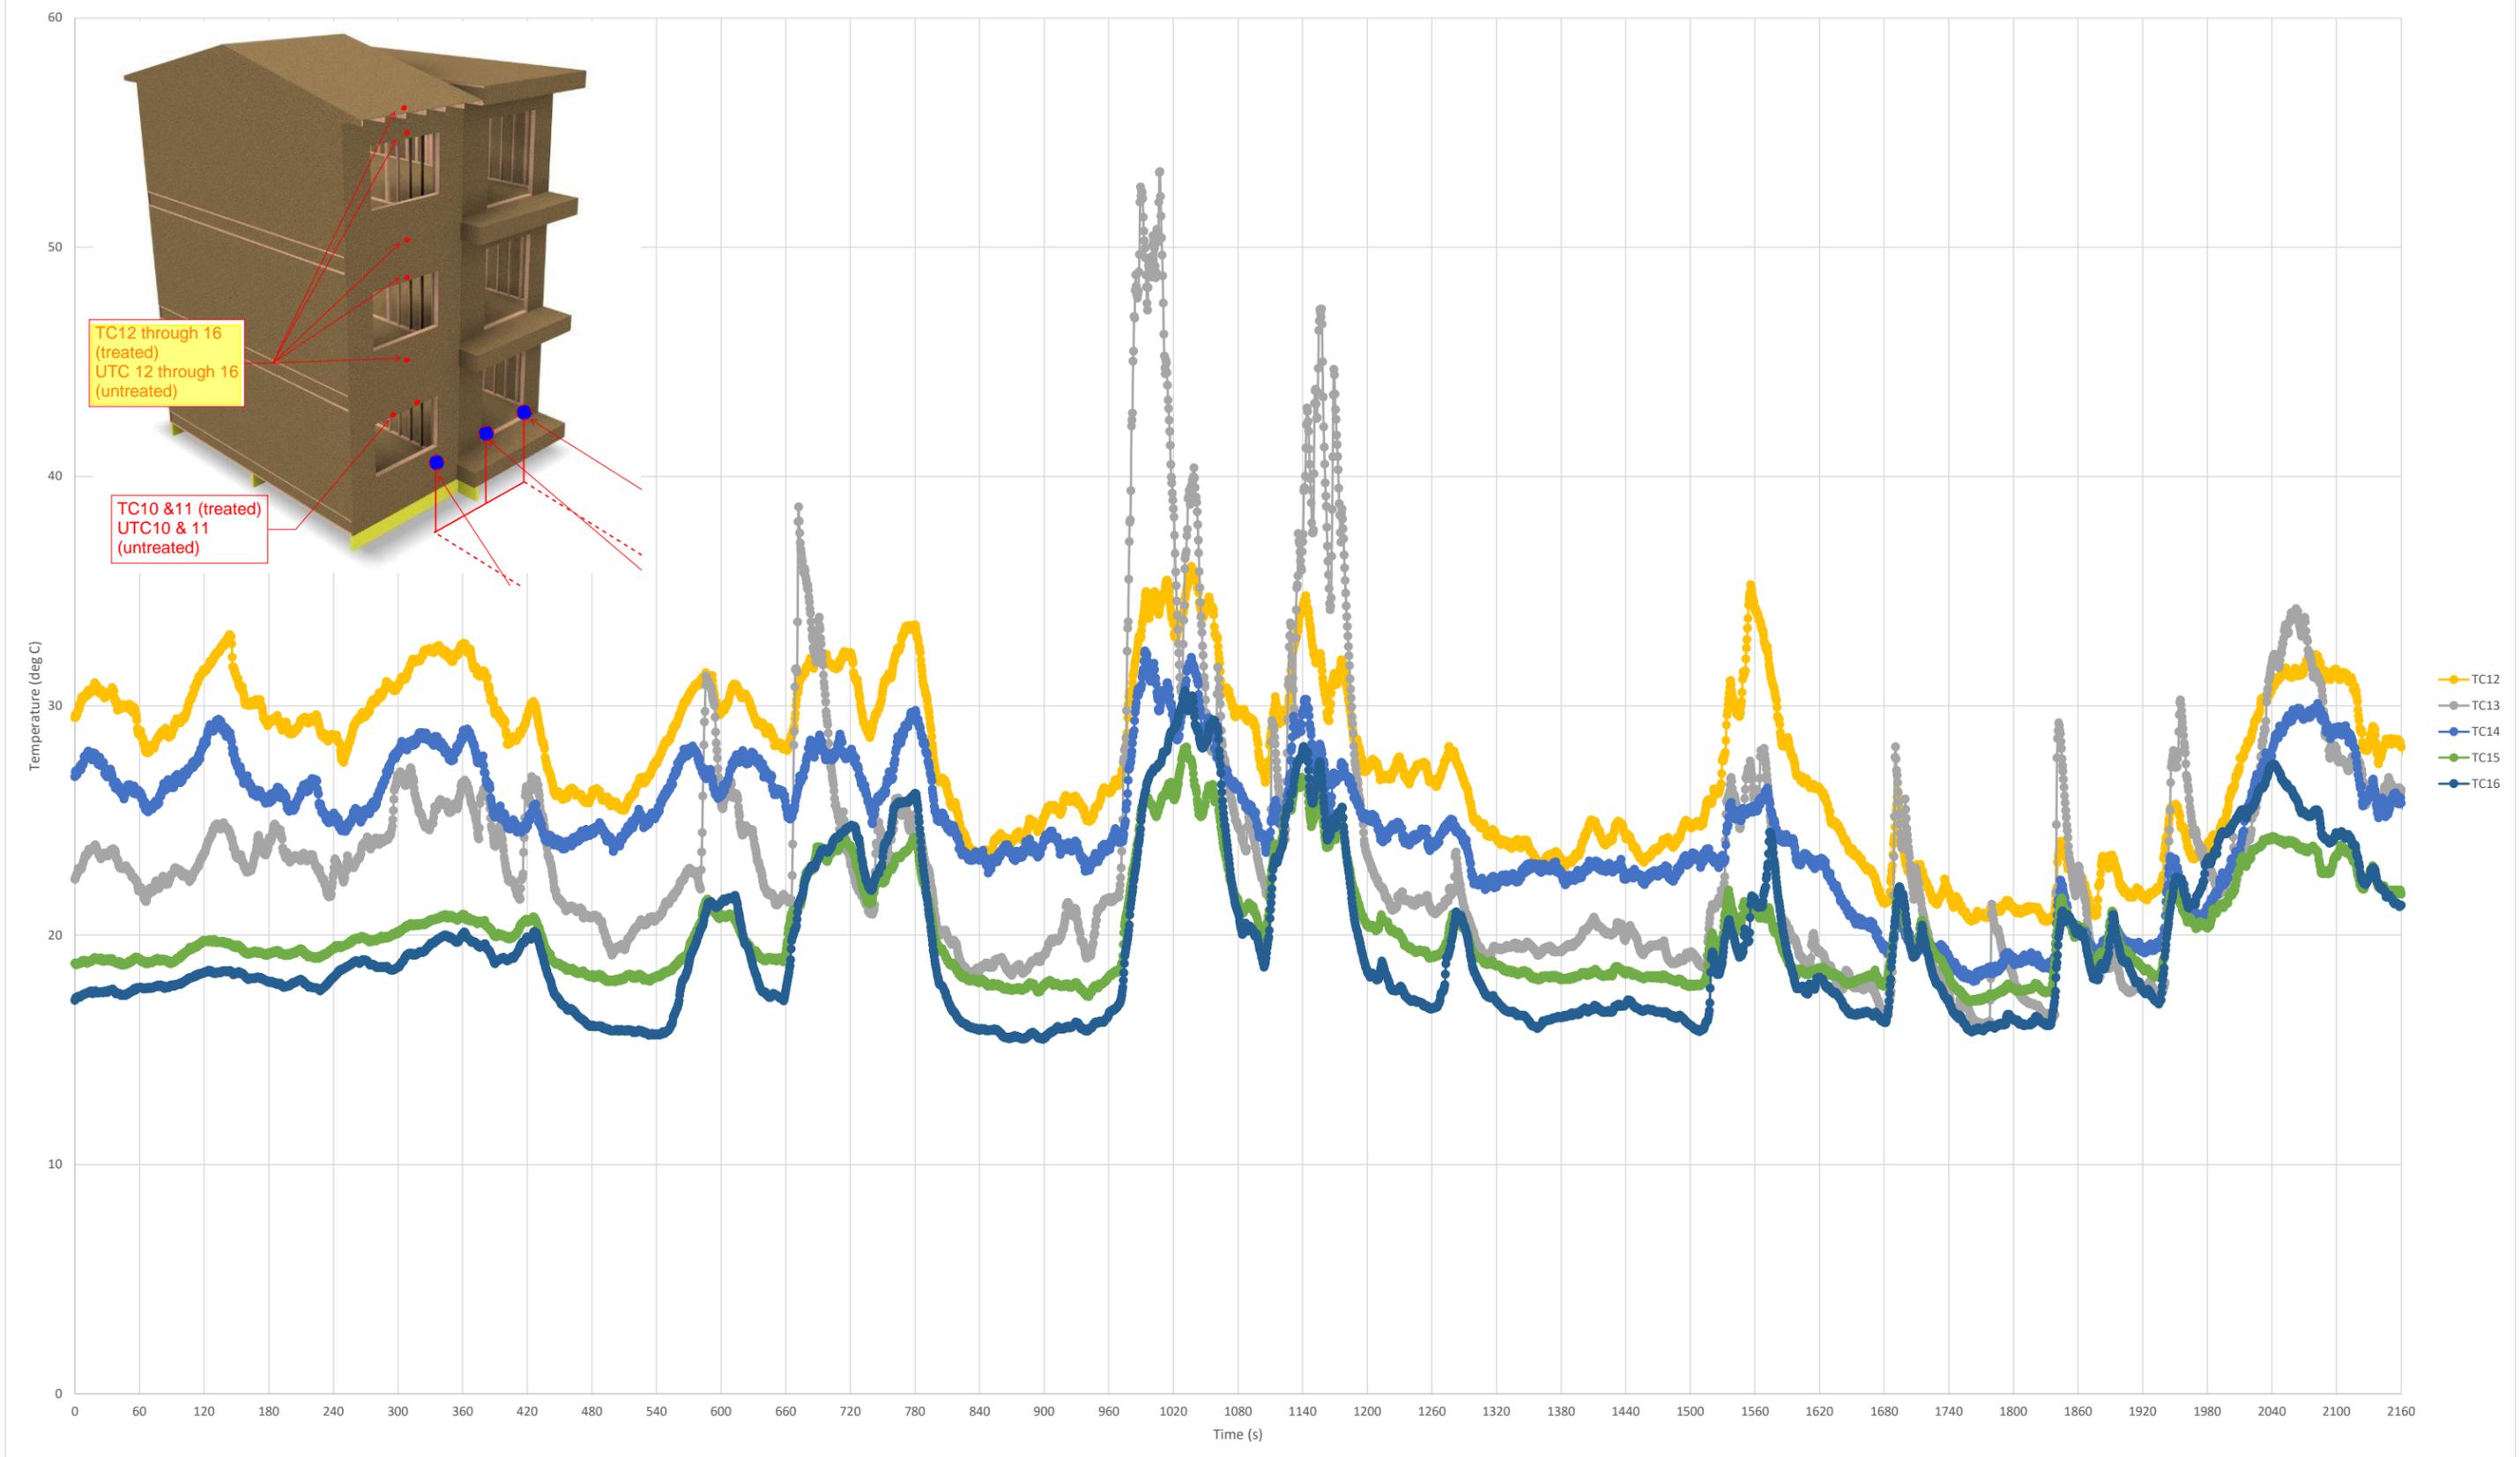
Figure 6

Treated Building Exterior Surface Temperature

quantitatively establish the impact of the coating on fire growth at faces which would be exposing building faces. [**See Figures 4 through 7 in Appendix A**]

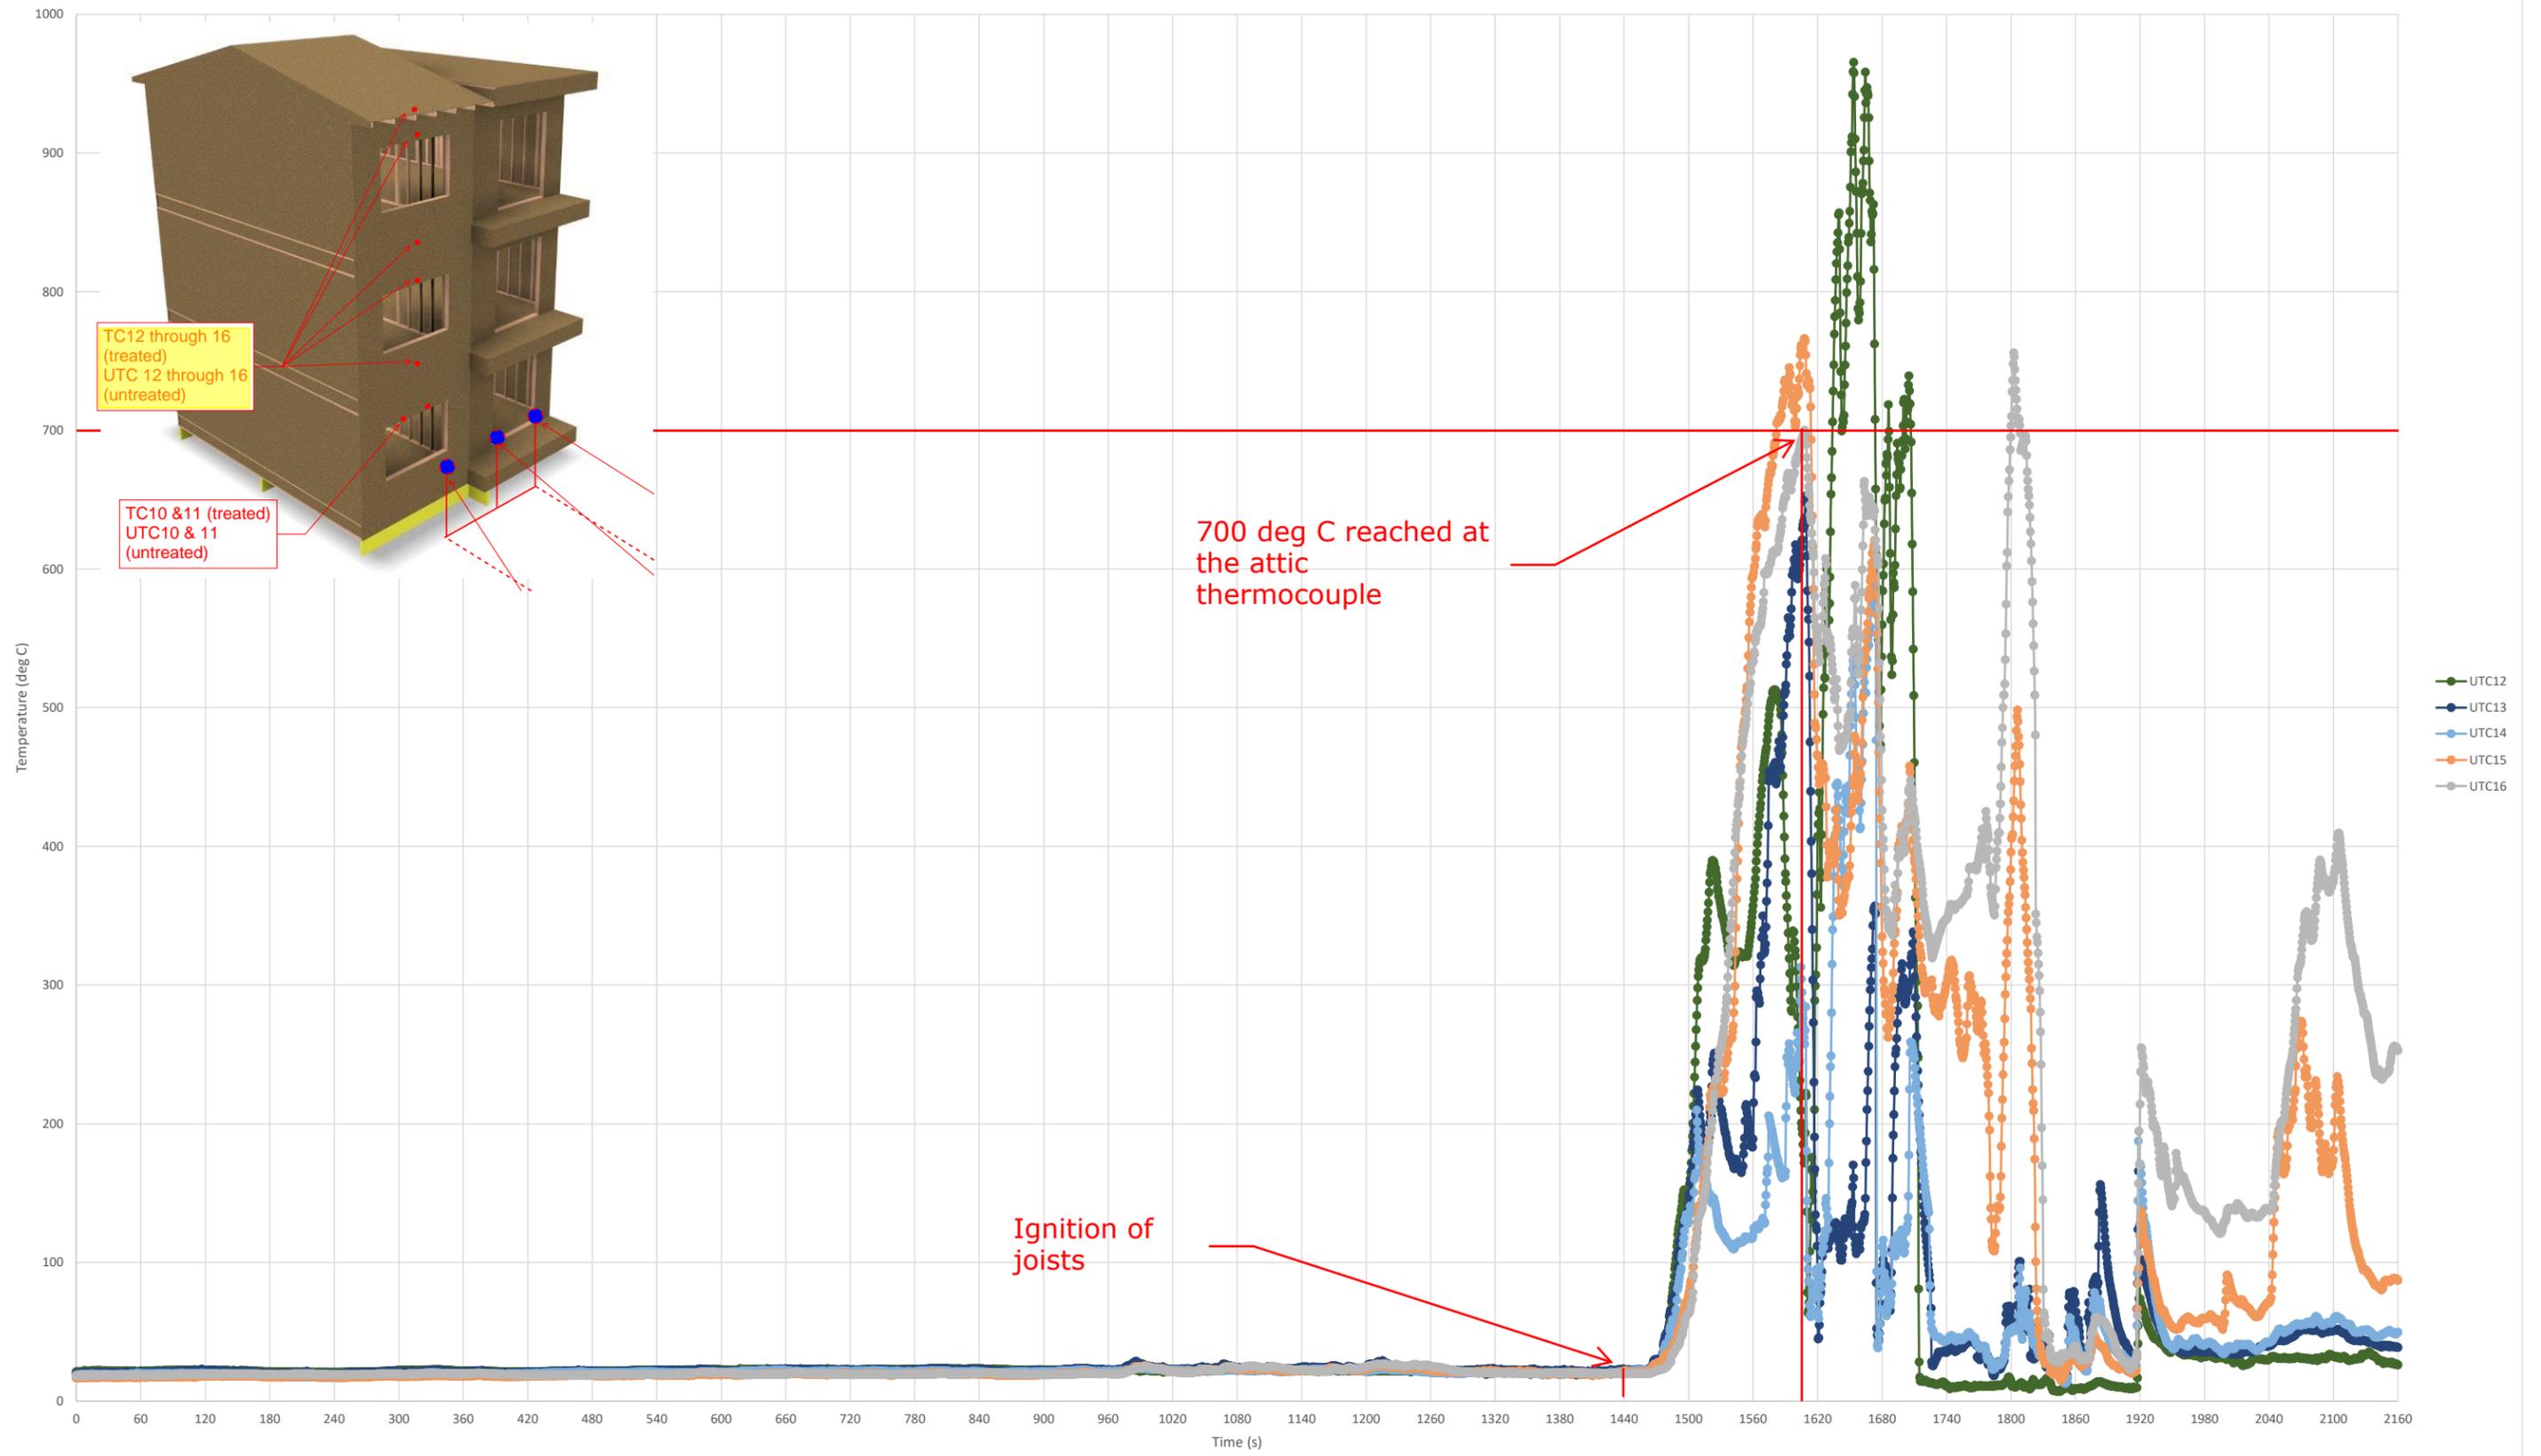
Figure 7

Untreated Building Exterior Surface Temperature

- A maximum vent temperature of 945°C was achieved prior to water application.
- Temperatures up the side of the untreated structure increased rapidly; attic temperatures of 700°C were reached at 1608 s, within three minutes of the onset of structural involvement in the fire, and under two minutes from flames venting through the first storey window [**Figure 7**].

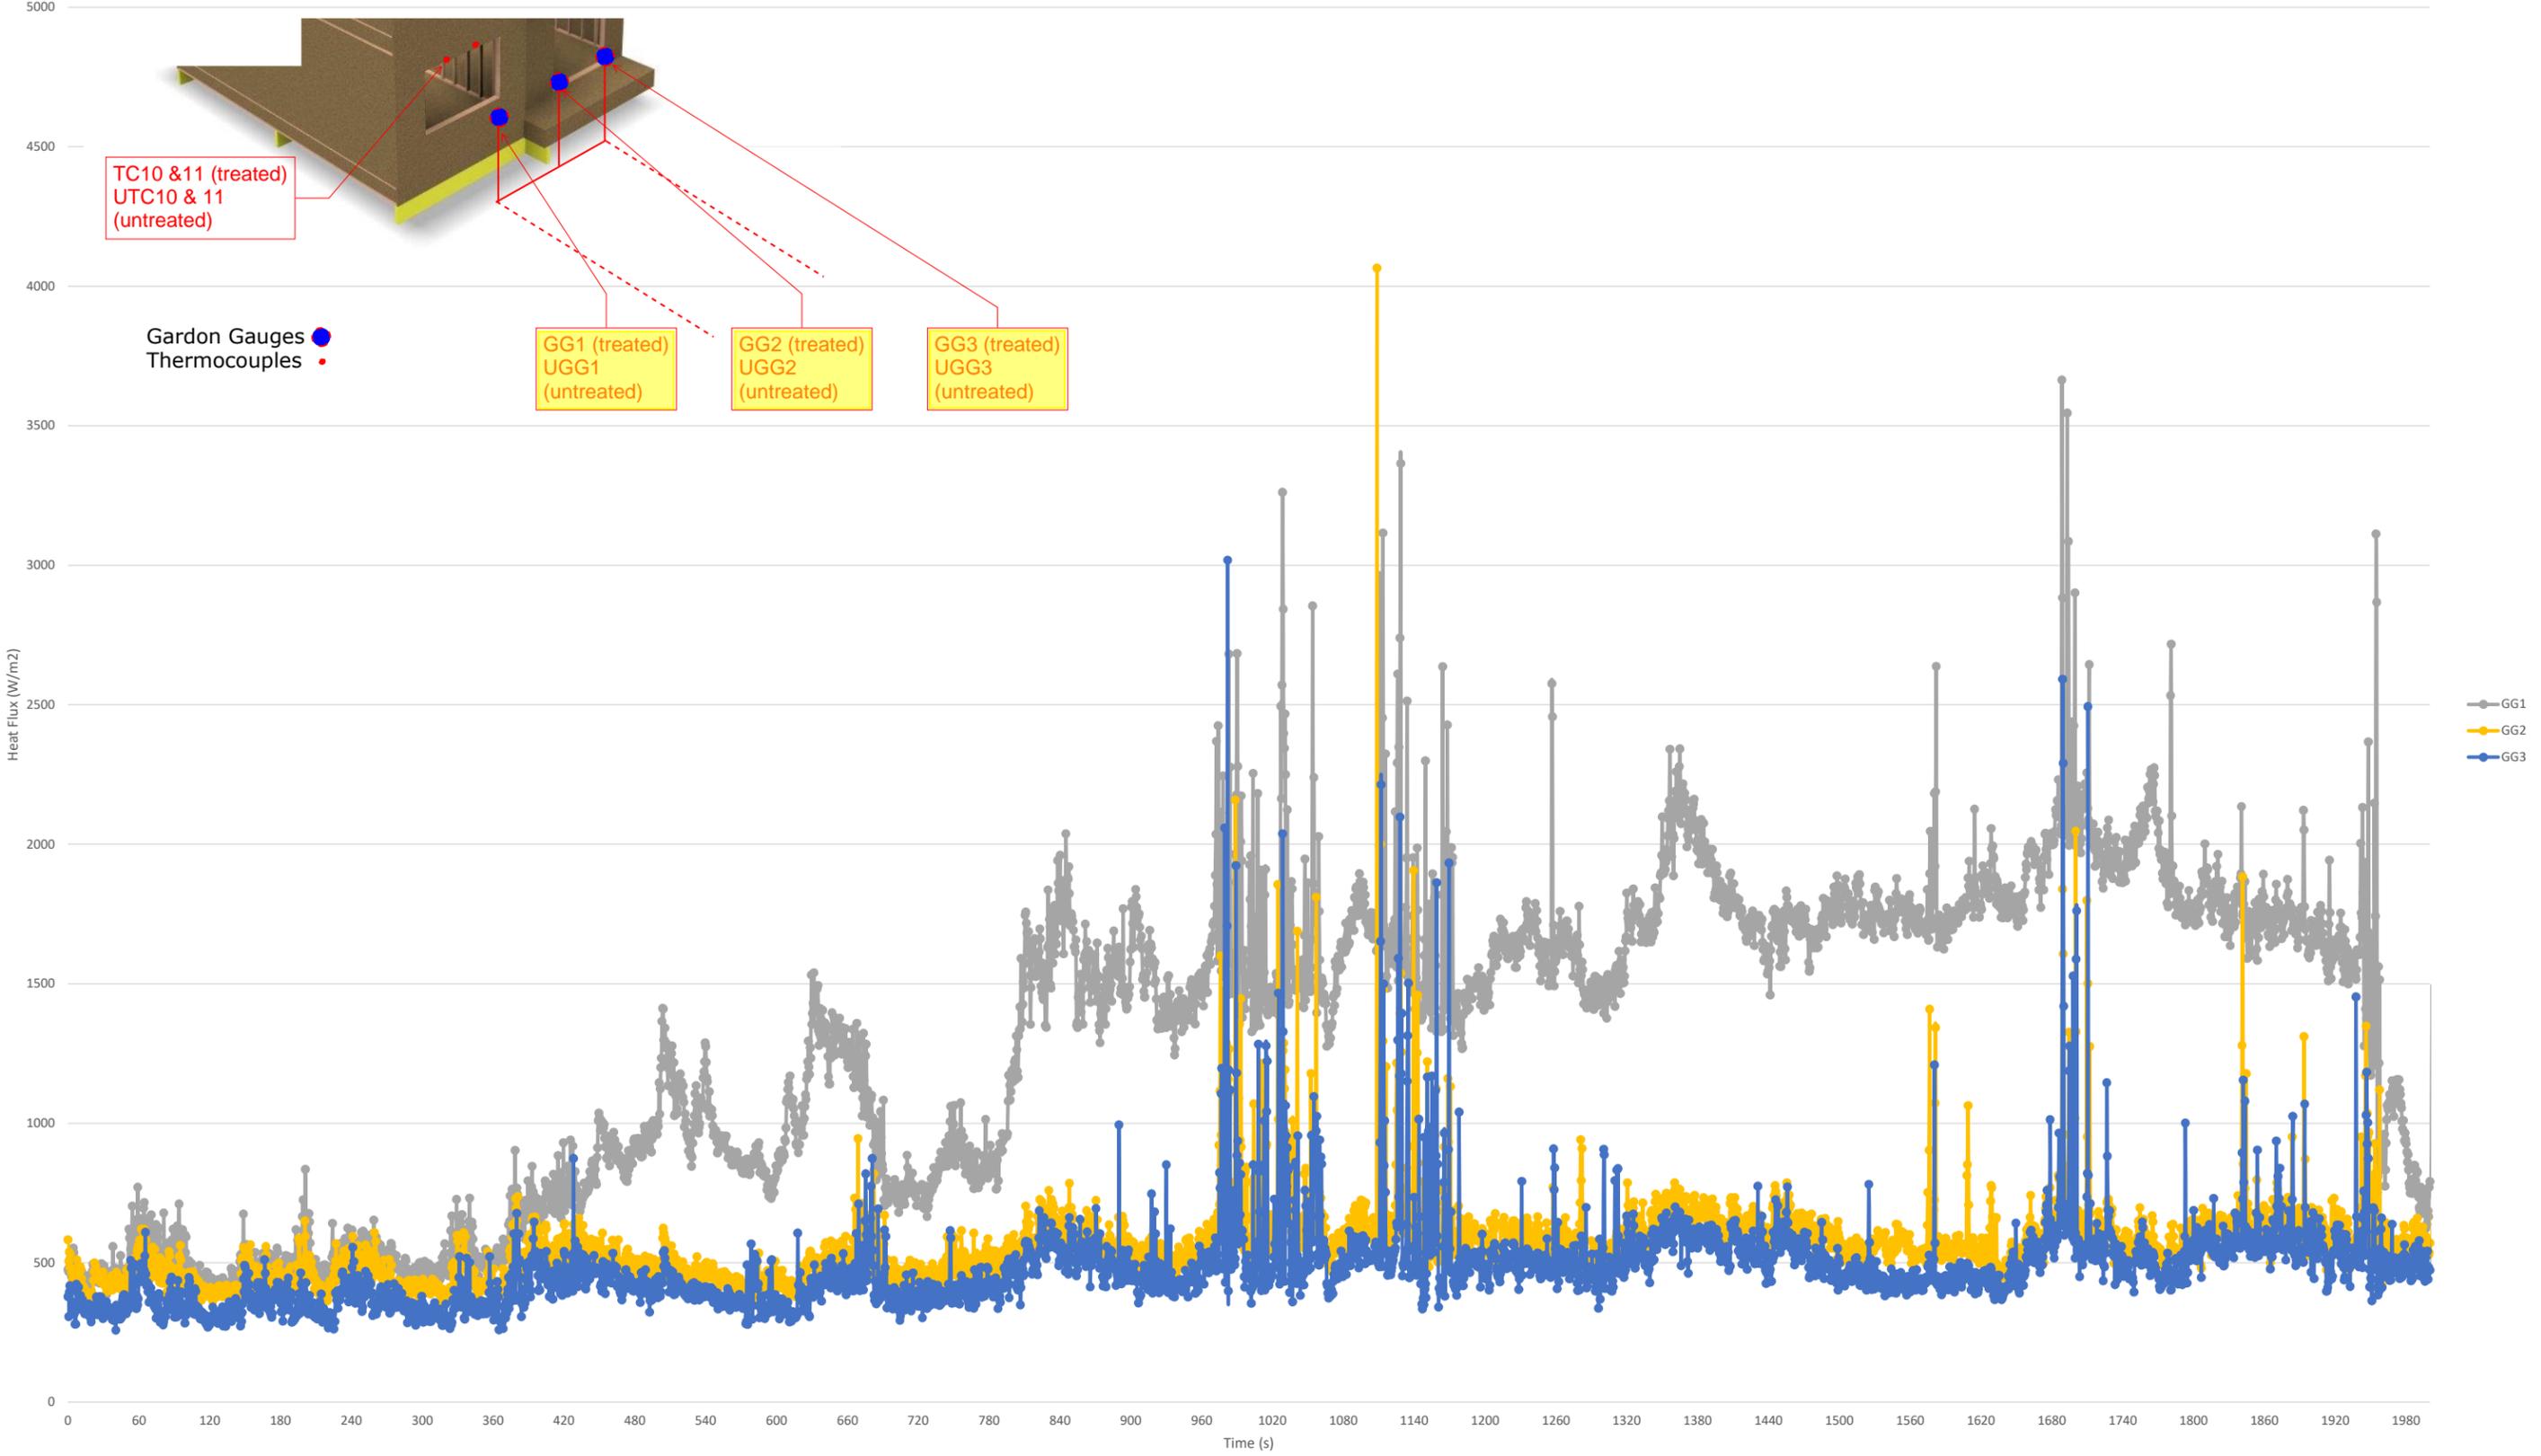
Figure 8

Treated Building Radiant Heat Flux

position was 2.4 m away, and the third position was 3.6 m away. The heat flux gauges in the treated building did not have to be moved due to the overall lower peak intensity of the fire. The gauges on the untreated building needed to be retracted past 3.6 m as the building became fully-involved and began collapsing. [See Figures 8 through 11 in Appendix A]

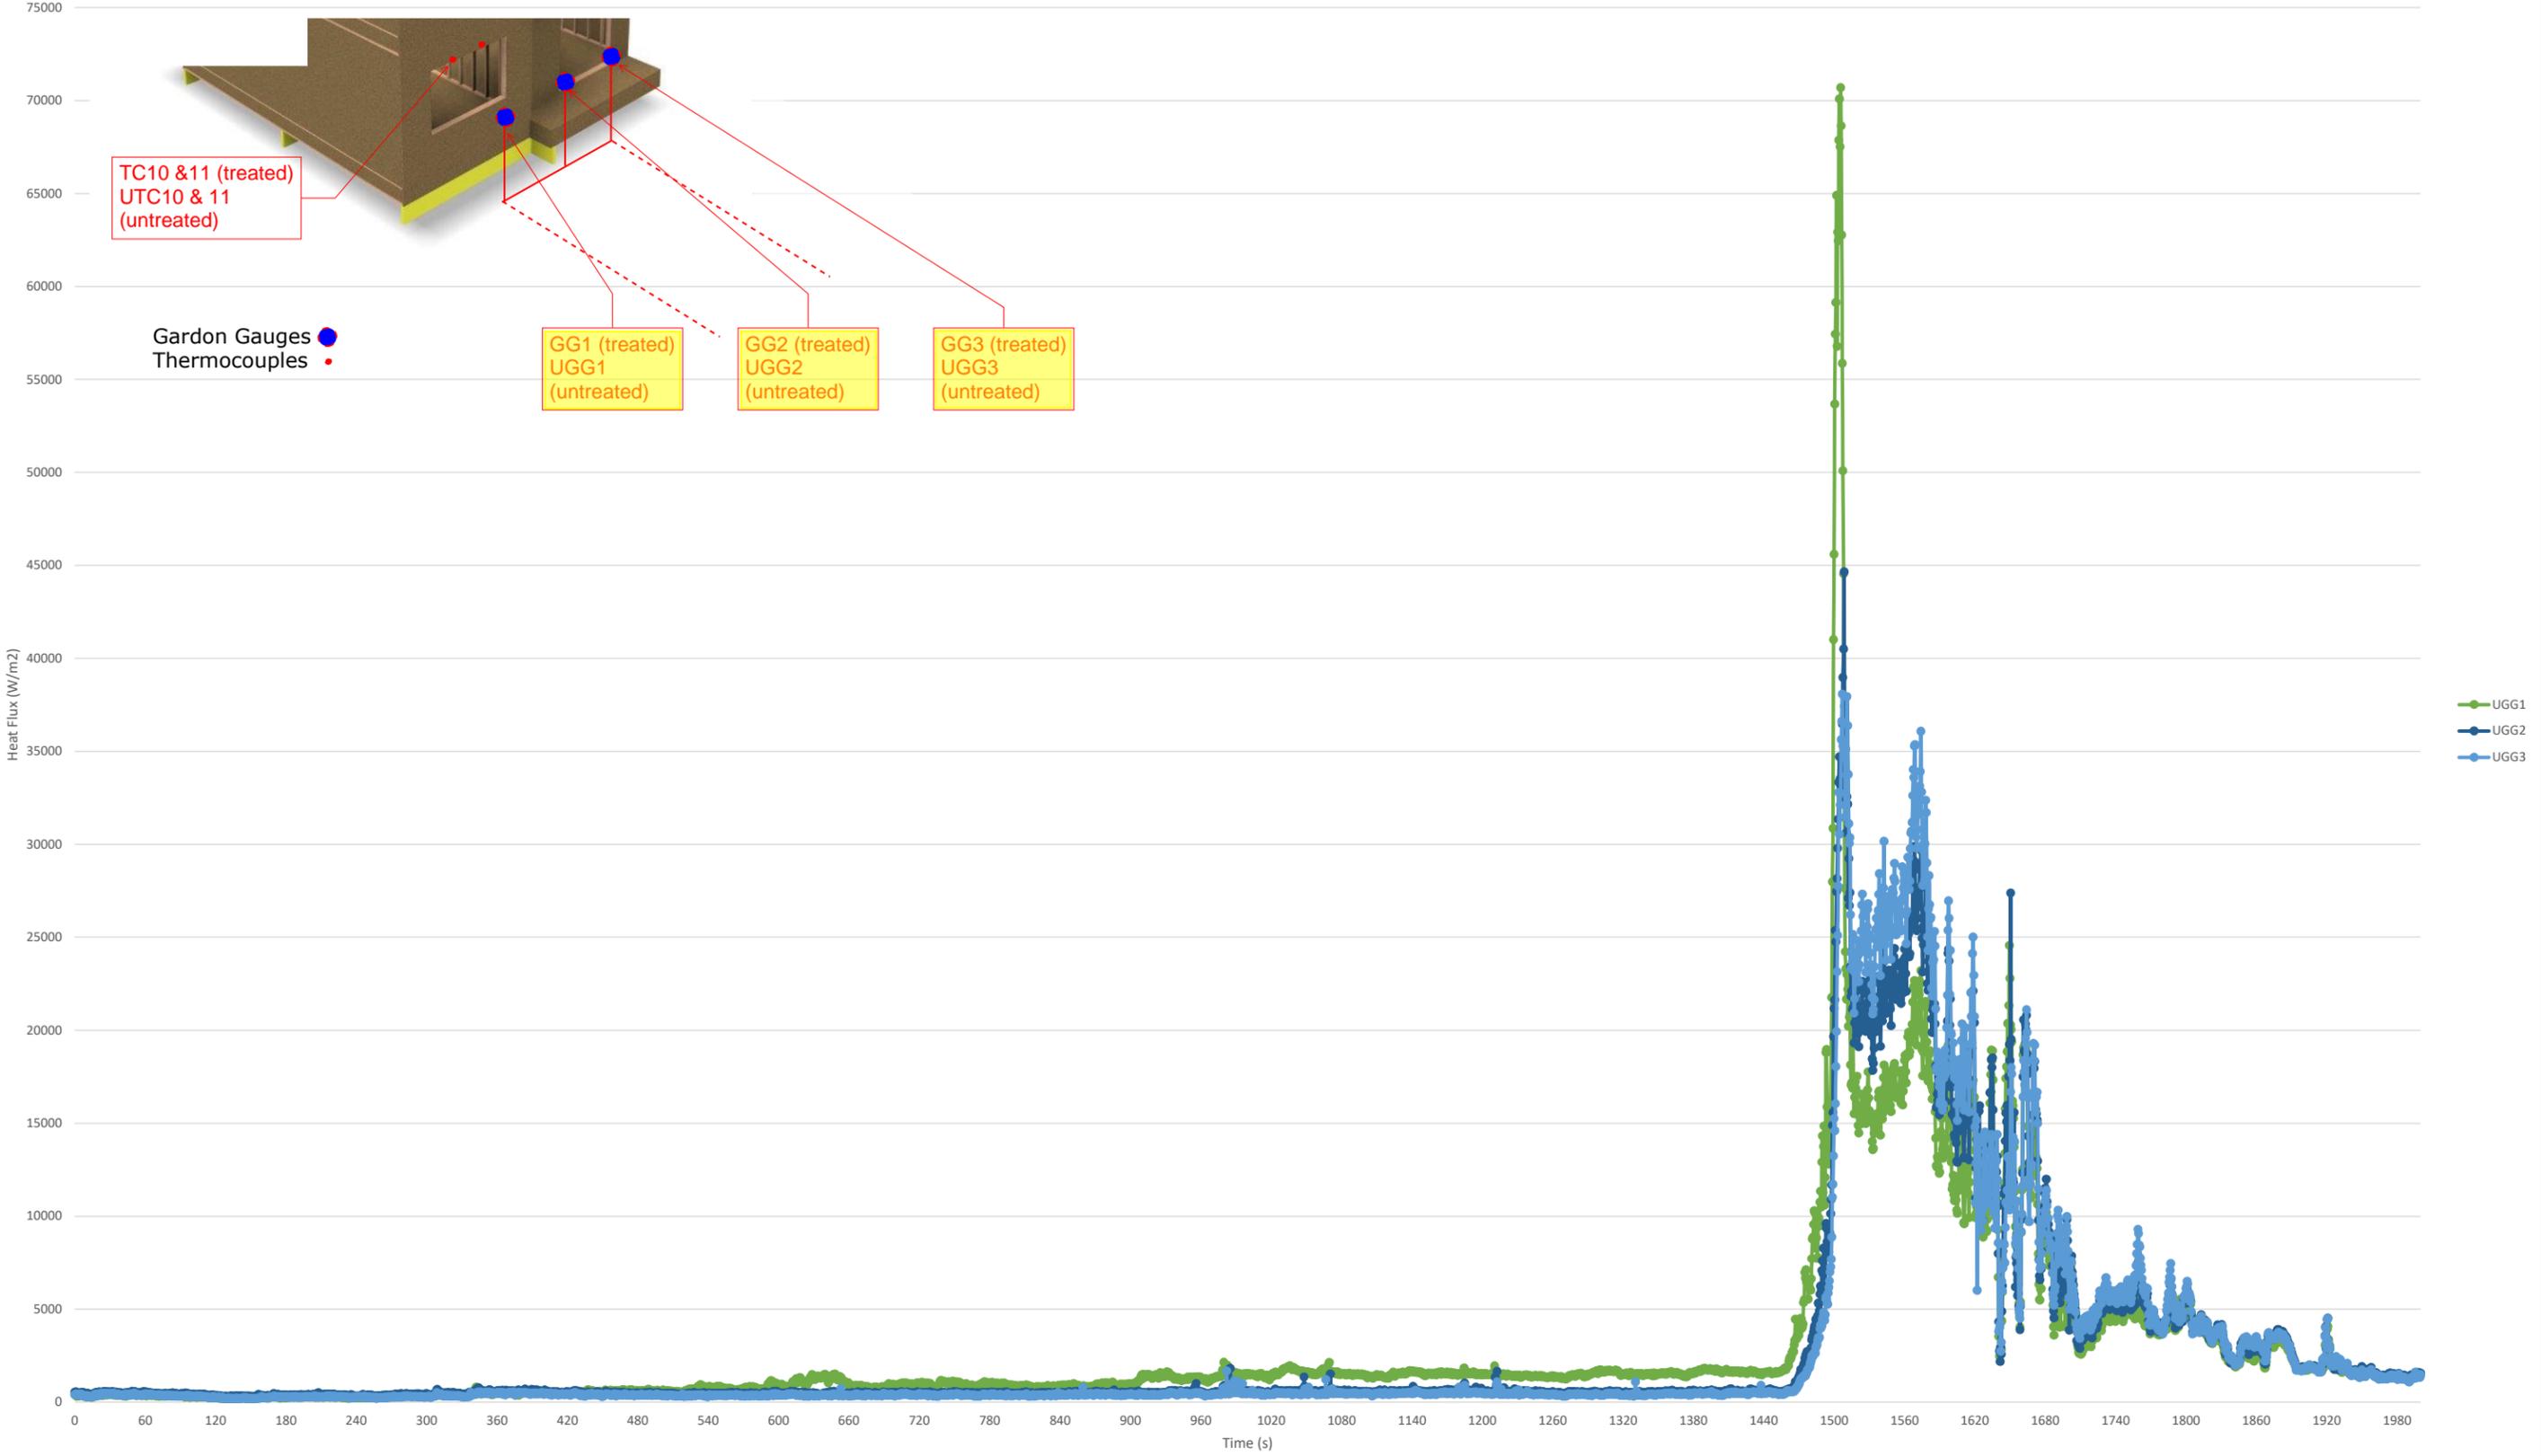
Figure 9

Untreated Building Radiant Heat Flux

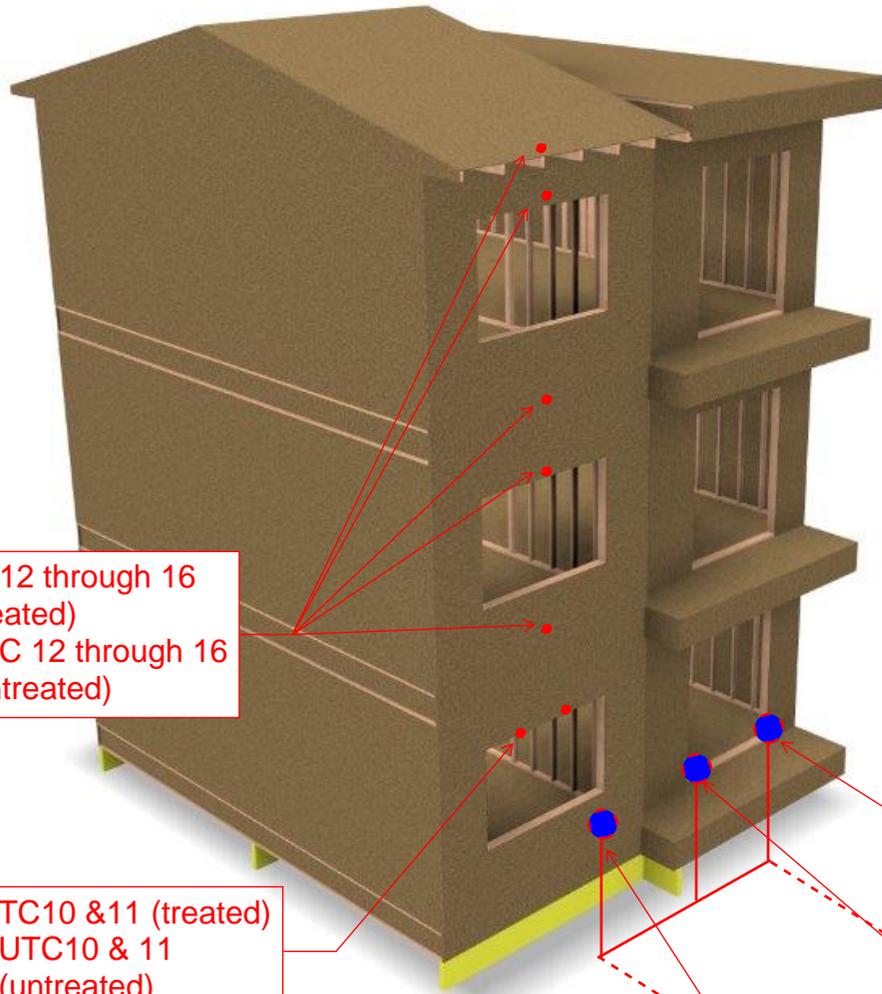
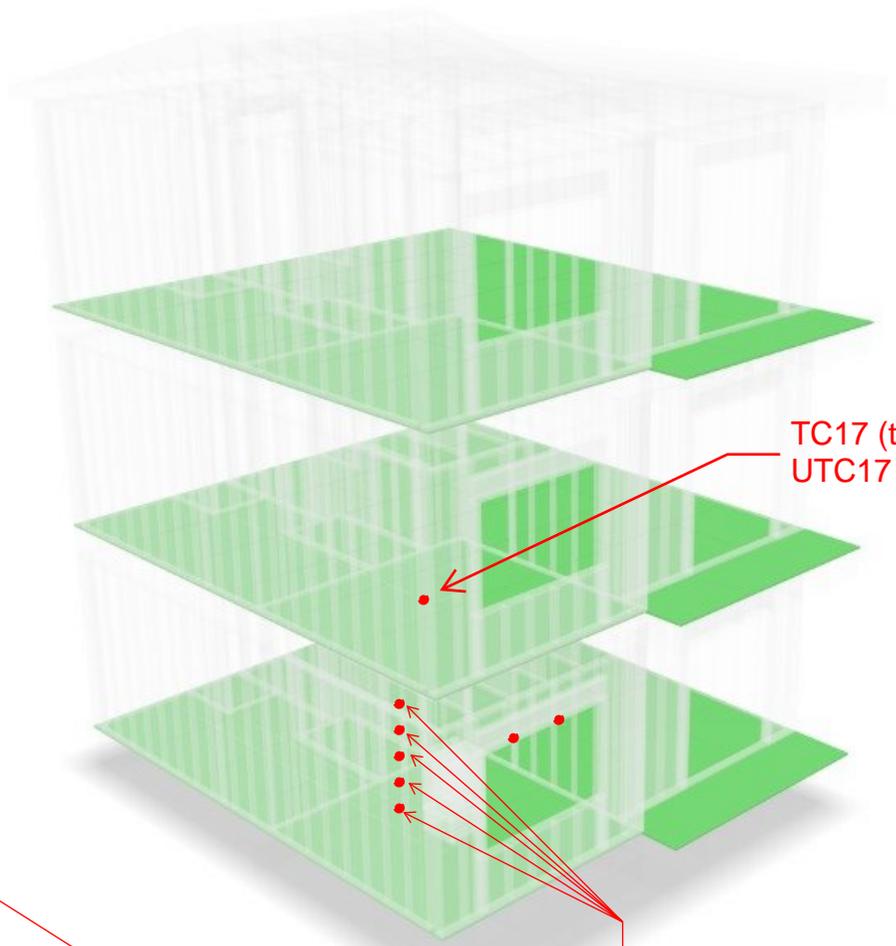
### BarrierTek Full Scale Testing Sensor Schematic

TC12 through 16 (treated)  
UTC 12 through 16 (untreated)

TC10 &11 (treated)  
UTC10 & 11 (untreated)

Sensors were positioned within and in front of the structures. Type K thermocouples were used for monitoring temperature, while Hukseflux Gardon Gauges were positioned outside the structures to monitor heat flux emanating from the buildings. 16 thermocouples were used in each structure, with three Gardon Gauges positioned across the front of the structure mounted to a repositionable sled [Drawing 2 & Appendix B].
