Treated Building Thermocouple Tree

Comparison of upper layer temperatures prior to structure catching fire

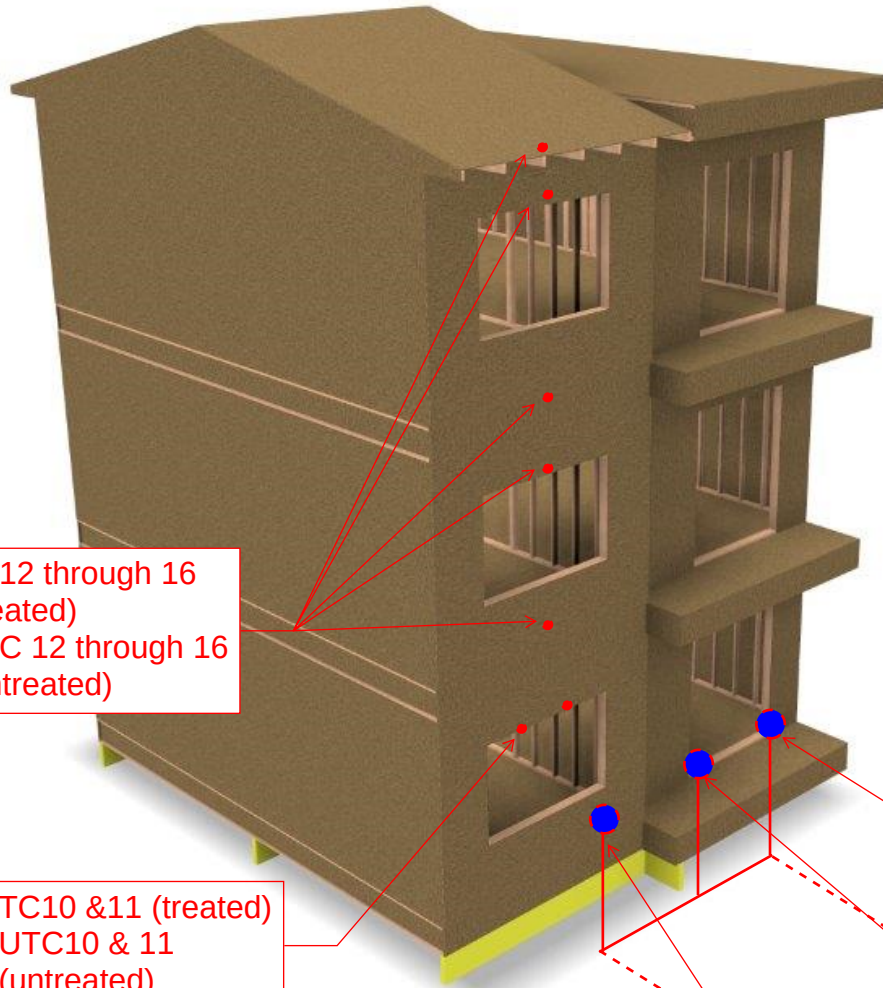
Gardon Gauges ●  
Thermocouples ●

GG1 (treated)  
UGG1  
(untreated)

GG2 (treated)  
UGG2  
(untreated)

GG3 (treated)  
UGG3  
(untreated)

TC/UTC 6-8  
inside LVL,  
not shown.
